2015 SEDIMENT TRANSPORT INVESTIGATION ON THE VANDERHOOF REACH OF THE NECHAKO RIVER

FINAL REPORT

NHC Ref. No. 3000854

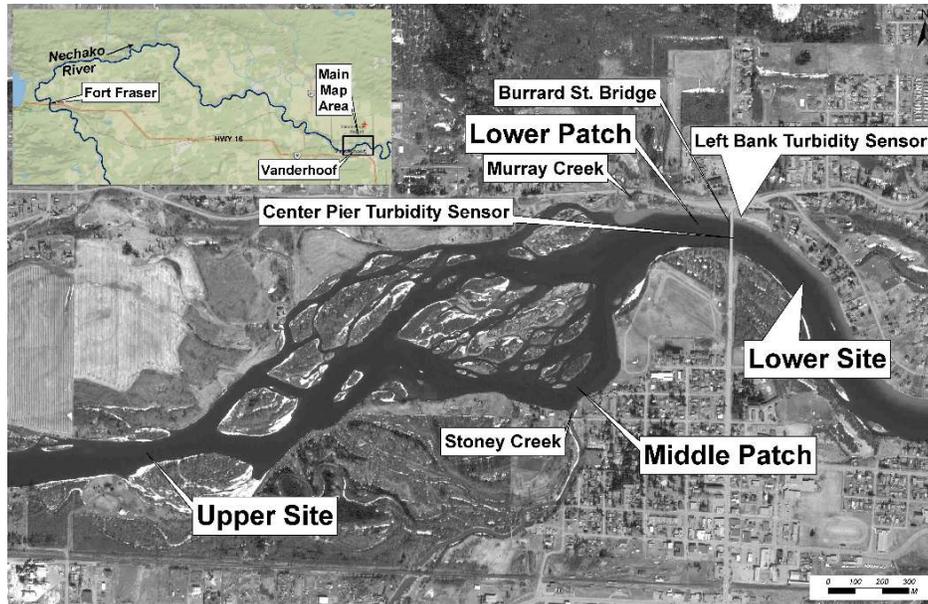
Figure 1 Nechako River at Vanderhoof BC. Spawning substrate was placed at the Middle and Lower Patch while the Upper and Lower Sites are composed of native substrate.

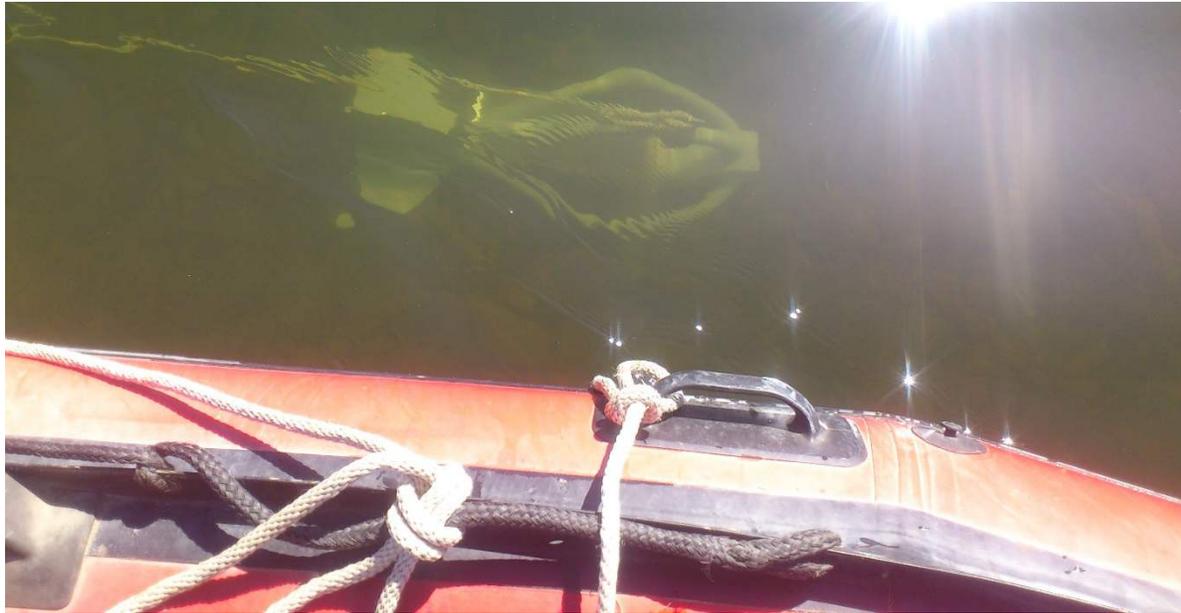
Figure 2 Helley-Smith sampler collecting a bedload sample in 2015.

In brief, a Helley-Smith sampler (Figure 2) with a 76.2 mm wide opening and 0.125 mm mesh bag was used to collect one sample from each vertical over a duration of 5 minutes. If transport rates were exceptionally high and the bag became full, additional samples were collected over shorter duration periods. To deploy the sampler, the boat was held in place using an anchor and the sampler was slowly lowered onto the bed. The rope was left slack and monitored to ensure there was no risk of the sampler being dragged due to lateral boat movement. During the period of peak flow, a larger Helley-Smith (Elwha River Sampler) with a 190.5 mm wide opening was used to reduce bias and under-sampling of coarse grains within the bedload. The Lower Patch sampling transect was originally established across the upstream portion of the spawning pad; however, due to concurrent biological research programs during the 2015 spawning period, the transect was temporarily displaced approximately 70 m in the upstream direction. All 2015 bedload samples were dried and individually weighed. Approximately half of the samples were then sieved at the UBC Geography Biogeomorphology Lab using ½ phi sieves. For the purposes of this report, grain size classification is based on the length of the b-axis, or the intermediate axis perpendicular to the longest axis. Grain size texture is defined using the Wentworth scale in Table 1.

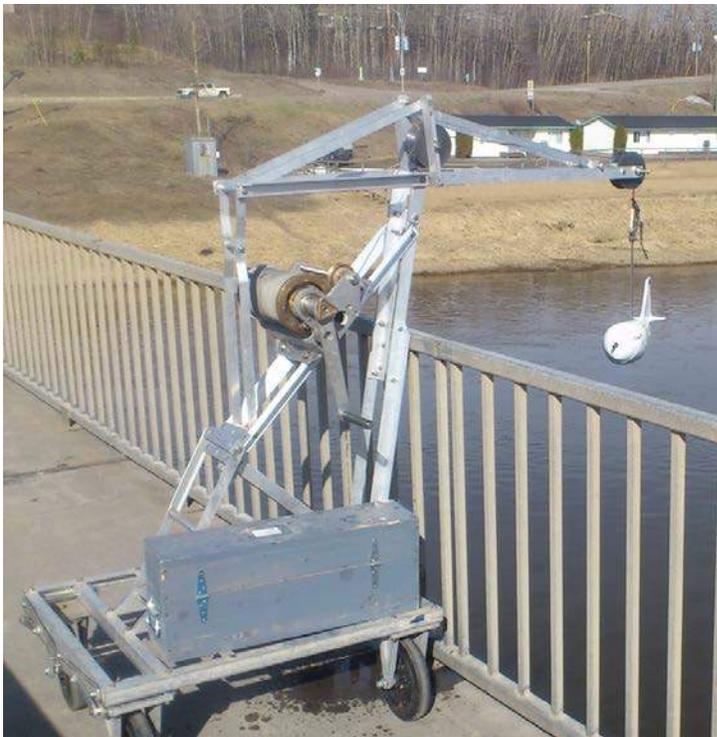
Figure 3 Suspended sediment sampler and bridge crane.

In brief, samples were collected with a Bridge Crane and D-74 depth integrating sampler (Figure 3). The winch on the crane, known as a B-reel, uses a brake shoe that is pressed against a brake pad to control the rate of descent and a crank to retract the cable. Target transit rate varied from 0.15 m/s to 0.25 m/s depending on stage and velocity. Nozzle size was selected to prevent overfilling of the sample bottles. Samples from each day were combined and sieved at the UBC Geography Biogeomorphology Lab. Samples collected on March 20th and 27th were not combined prior to sieving to isolate the channel section affected by Murray Creek.

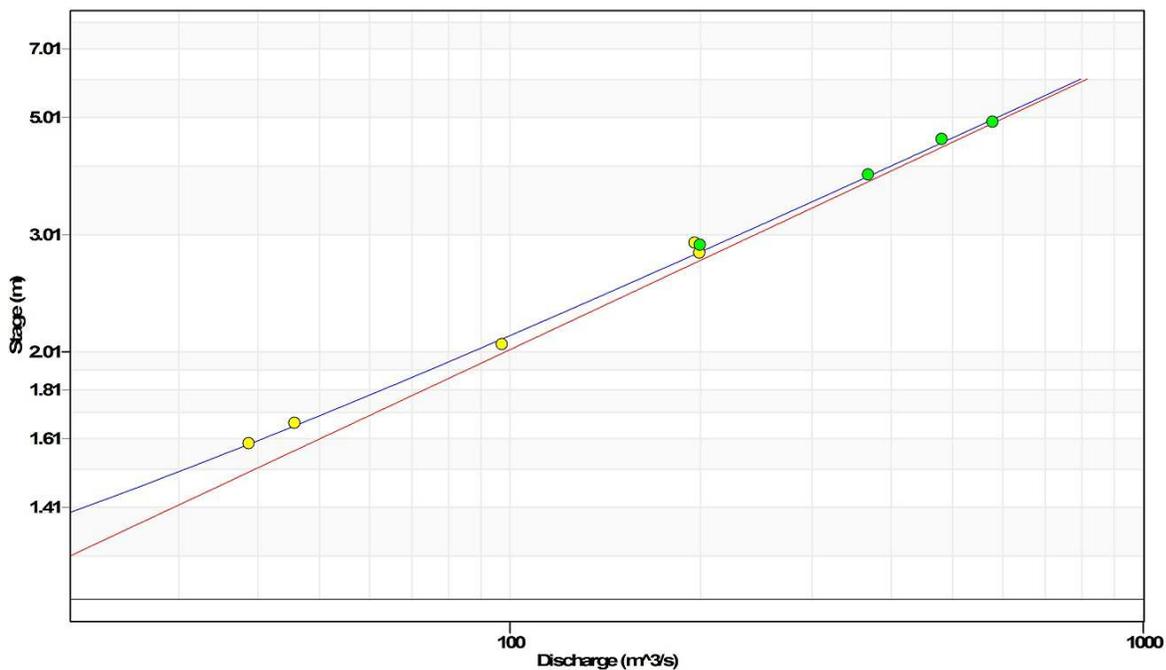
Figure 4 NHC stage-discharge rating curve shown in blue, WSC curve in red. Measurements taken during 2014 and 2015 are shown in yellow and green, respectively.

Stage and discharge measurements taken in 2015 by the Water Survey of Canada (WSC) were used to refine the high flow portion of the NHC stage-discharge rating curve developed in 2014 (NHC, 2015) (Figure 4). High flow measurements were taken during April and May of 2015 reaching a maximum measured discharge of 578 m³/s. The rating curve shift applied in 2014 to account for apparent aggradation of the reach was maintained in 2015 because low flow measurements between 200 m³/s and 480 m³/s continue to plot in agreement. The curve-derived discharge time-series was corrected to remove all ice effects occurring from 2013 to present and shows good agreement with WSC measured discharge values (Figure 5). In 2015, daily discharge reached a maximum of 676 m³/s on June 6th. This is the third highest annual daily discharge since the onset of flow regulation in 1952 (Figure 6); the highest being 786 m³/s in 2007.

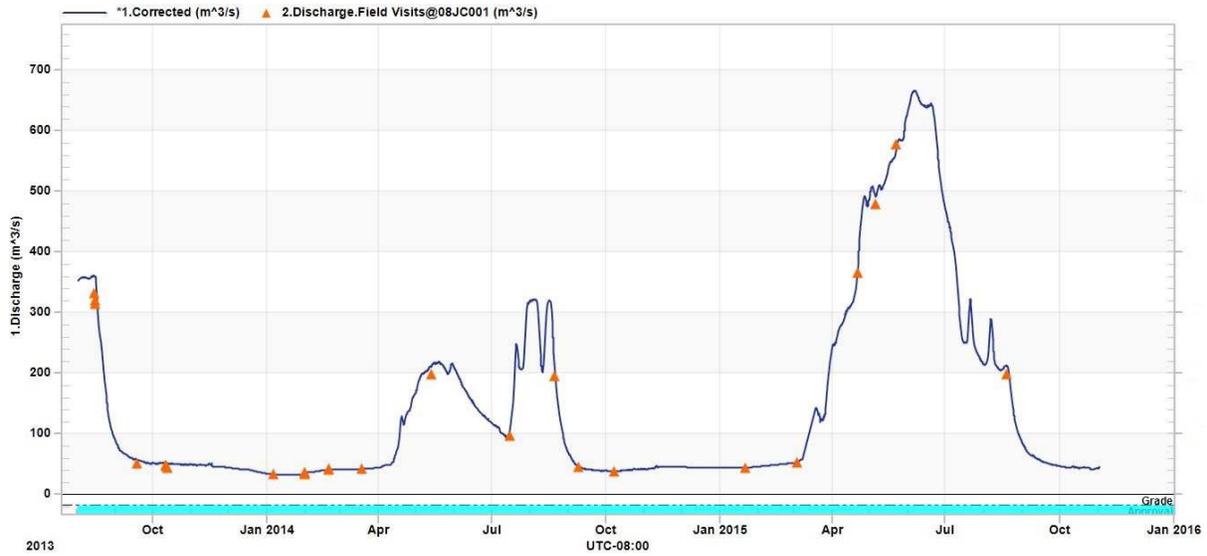
Figure 5 NHC rating curve derived discharge time-series compared to WSC measured values.

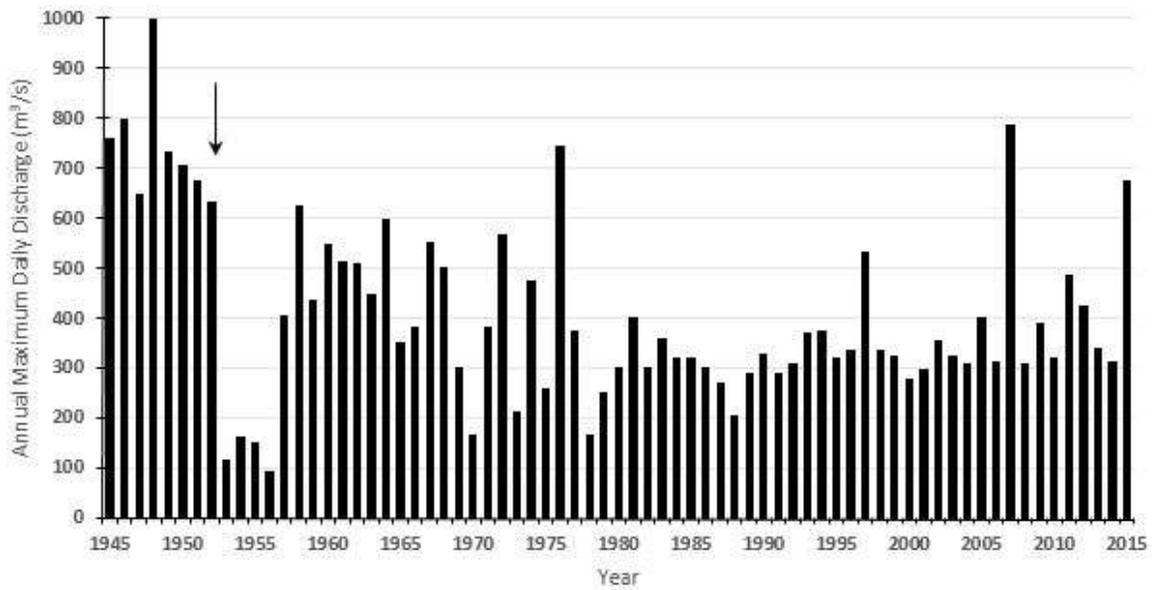
Figure 6 Annual maximum daily discharge for the Nechako River at Vanderhoof. Arrow indicates the onset of flow regulation.

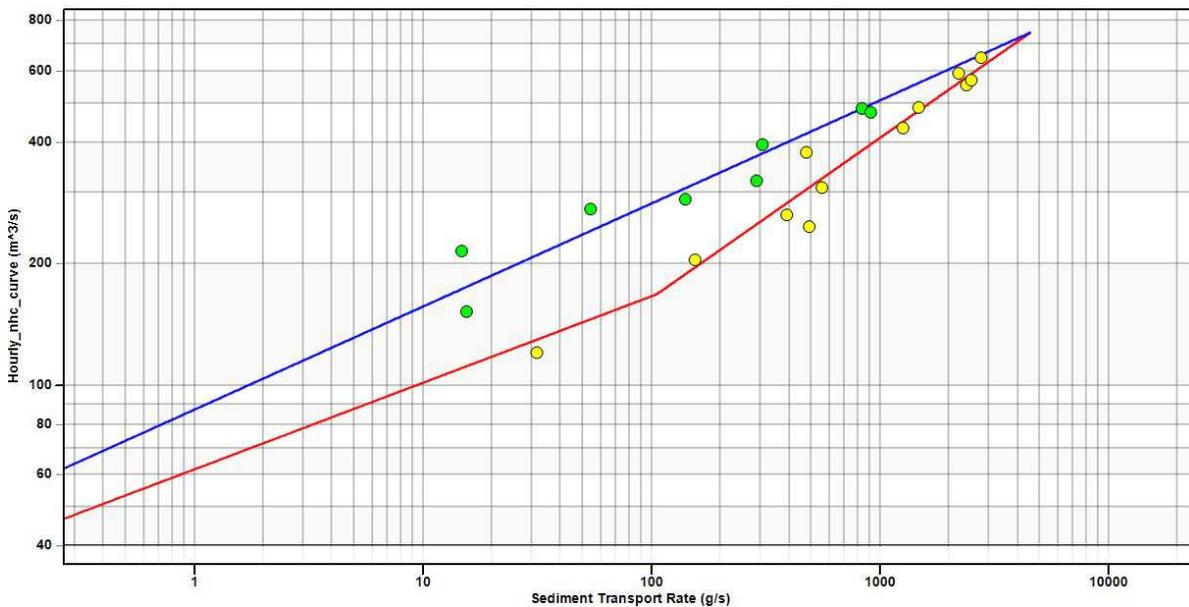
Figure 7 Bedload rating curve developed for the Upper Site showing hysteresis. Transport rate during the rising limb of the 2015 hydrograph is shown in red, transport during the receding limb in blue.

Data collected at the Upper Site suggests that the supply of bedload sediment became limited during the period of peak annual flow in June. This supply limitation is shown by the hysteresis in Figure 7, where sediment transport declines at a greater rate per unit discharge during the receding limb of the hydrograph. Two separate bedload-discharge rating curves were developed for the Upper Site in order to accurately represent these different transport rates. The rising and falling limb rating curves were applied to the 2013, 2014 and 2015 hydrographs to obtain the annual estimates of sediment transport in Table 2. Predicted daily bedload transport at the Upper Site is in surprisingly good agreement with measured values given the inherent variability associated with sediment transport processes (Figure 8).

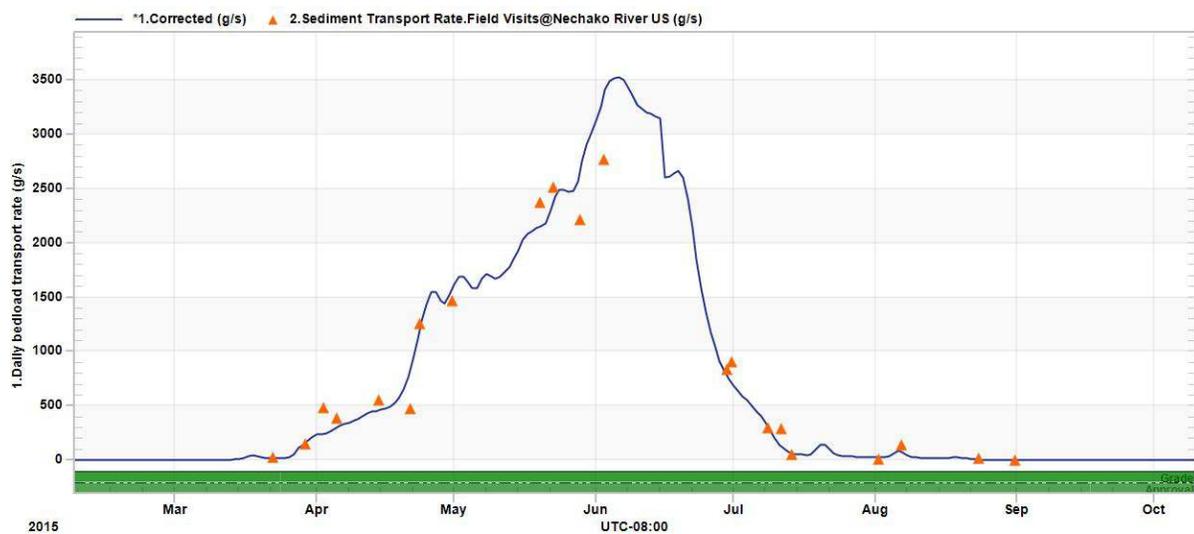
Figure 8 Predicted versus observed bedload transport rate at Upper Site in 2015.

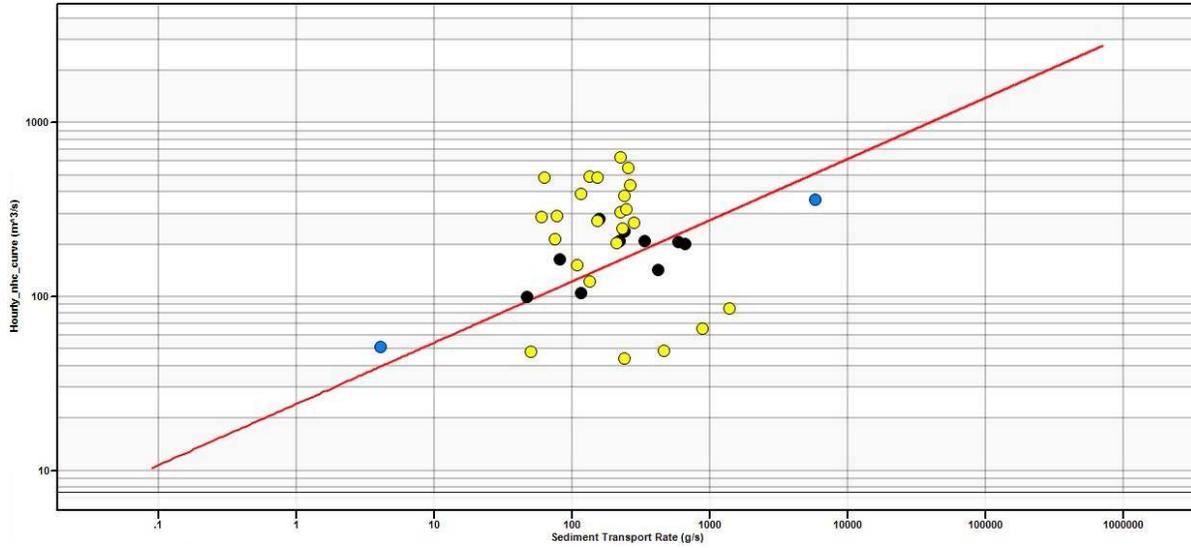
Figure 9 Bedload transport at the Lower Patch showing no clear relation with discharge in 2015. Samples taken in 2015 are yellow, 2014 are black and 2013 are blue. The rating curve used in 2014 is shown in red.

Bedload transport at the Lower Patch showed no clear relation with discharge and therefore no rating curve could be used to derive the 2015 annual sediment load (Figure 9). Rather, the estimated 3,050 m³ in Table 2 was calculated by interpolating daily transport rates between sampled days. The Lower Patch bedload rate remained relatively constant between 100 and 300 g/s/transect for the majority of 2015 until the greatest transport rate of 1,384 g/s/transect was sampled on August 31st at a discharge of approximately 80 m³/s. The inverse relation between transport rate and discharge occurs because local velocity and bed shear stress are decreased during high flow as a result of backwatering upstream of the Burrard Avenue Bridge (NHC, 2008).

The Lower Patch bedload rating curve was shown to be non-applicable during high flow, backwatered conditions (Figure 9). Consequently, estimates of annual transport during high discharge years such as 2007 are highly uncertain. One possible way of achieving better bedload estimates at the Lower Patch is to develop a rating curve using shear stress rather than discharge. To do so, hydrodynamic model simulations would need to be run to determine near-bed shear stress for a range of discharge values. This could be accomplished using a previously developed flow model (NHC, 2008).

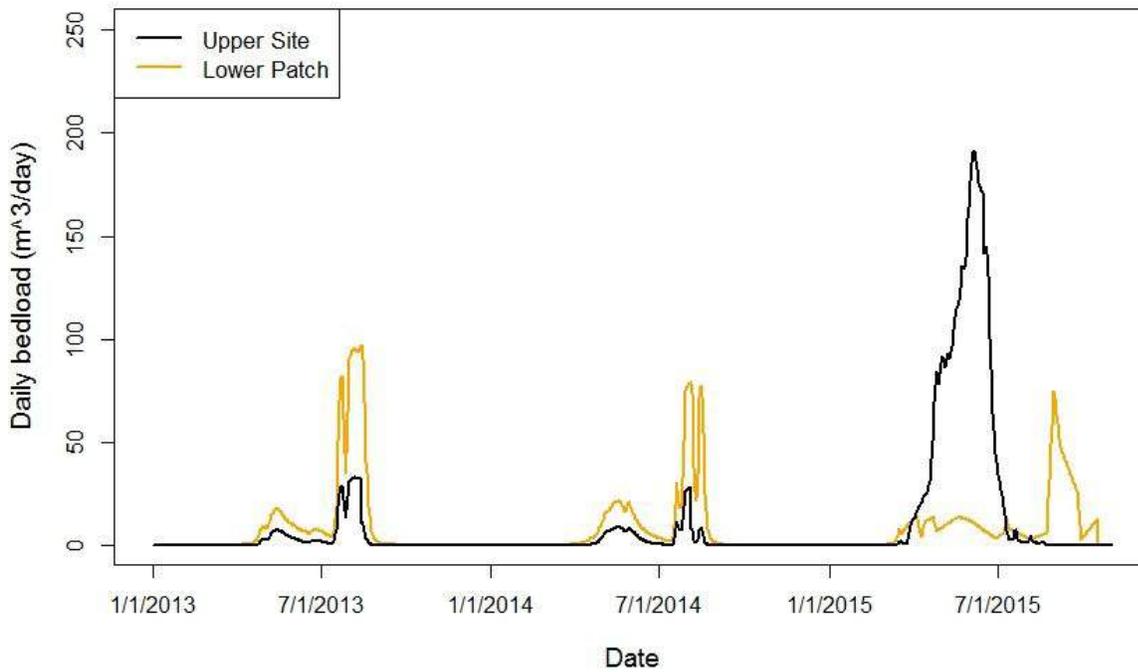
Figure 10 2013-2015 daily bedload at Upper Site and Lower Patch.

The maximum daily bedload transport rate is predicted to have been roughly 2.5 times greater at the Upper Site than Lower Patch (Figure 10), translating to values of 190 m³/day and 75 m³/day respectively. The daily bedload rate at the Upper Site exceeded 75 m³/day for 61 consecutive days between April 25th and June 24th, 2015. The significant difference in bedload transport between the upstream and downstream extent of the reach suggests 6,200 m³ of sediment has been stored within the reach in this year (Table 2). This net storage is interesting because previous years have observed the opposite trend with more sediment being output from the reach than input (NHC 2014; NHC, 2015).

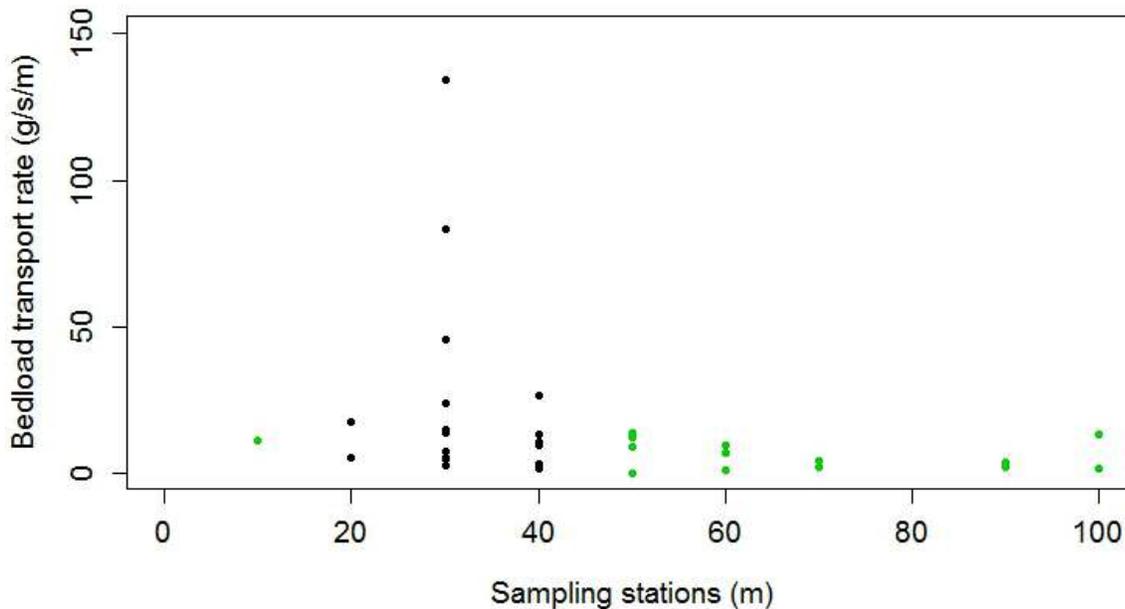
Figure 11 Site with the highest sampled bedload transport using 2013 to 2015 data. Black points correspond to the location of the Lower Patch.

The location of highest sediment transport past the Lower Patch has remained fairly consistent over time (NHC, 2014). Figure 11 plots the site with the highest sampled bedload per field visit from 2013 to 2015, omitting the 284.42 g/m/s sampled near Site LP 5 on August 15th, 2013. The majority of bedload seems to be transported past the Lower Patch within a 40 m wide portion of the channel between LP 2 and LP 6, with sites LP 3 and LP 4 most frequently conveying the largest amount. Site LP 3 also transports the greatest magnitude of bedload, however the three highest rates were sampled between August 31st and September 26th, 2015 within a very narrow overall active width. Therefore, it seems reasonable to conclude that most bedload transport occurs at Sites LP 3, LP 4 and LP 5 at rates of 10 to 25 g/m/s during periods of high transport.

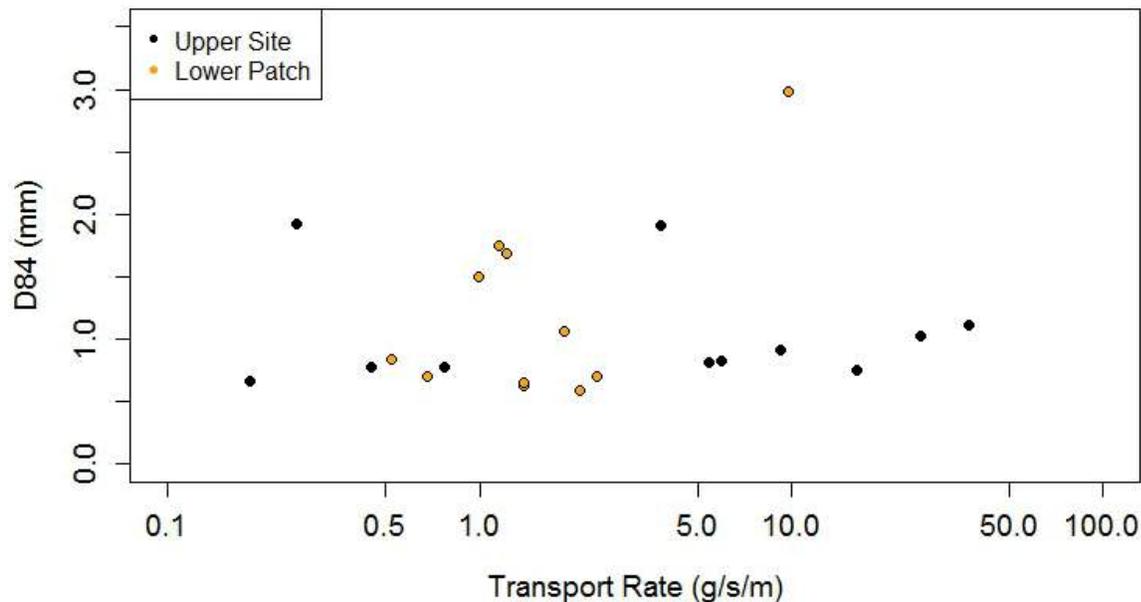
Figure 12 D₈₄ grain size of bedload at Upper Site and Lower Patch.

The grain size of the bedload sediment does not show a clear relation with increasing transport rate (Figure 12) and was almost entirely sand finer than 2 mm at both sampling sites over the course of the year. Very coarse gravel (45-64 mm) was transported as bedload at the Upper Site on May 28th and June 2nd, 2015 at discharges of approximately 600 m³/s and 650 m³/s, corresponding to the highest sampled discharges. However, this very coarse size fraction constituted only 1.4% and 4.4% of the total sampled mass for each date. In fact, only 4% of the May 28th and 7% of the June 2nd sample was coarser than fine gravel (8 mm).

No trend was observed between the grain size distribution of bedload material and increasing discharge or transport rate (Figure 12). The lack of a rapid increase in bedload grain size indicates that the coarse substrate armoring the bed at the Upper Site did not become mobile during the highest observed flows. Calculations using the bathymetric survey data indicate that the Upper Site had a shear stress of 17.0 Pa during a discharge of 525 m³/s. This estimated stress would have been sufficient to mobilize grains up to 17.5 mm assuming a Shields parameter of 0.06 is appropriate. In contrast, the bed at this location is largely composed of sediment in the 64-180 mm range, suggesting shear stress was insufficient to move the D₅₀ grain size. The very low proportion of gravel within the bedload likely occurs because sand is the dominant size fraction of sediment being input to the channel (Rood, 1999) and because of bed structuring that decreases larger grain mobility. Therefore, suitable interstitial habitat within the reach is more likely to be provided by processes such as winnowing and sediment sorting than by the mobilization of coarse material.

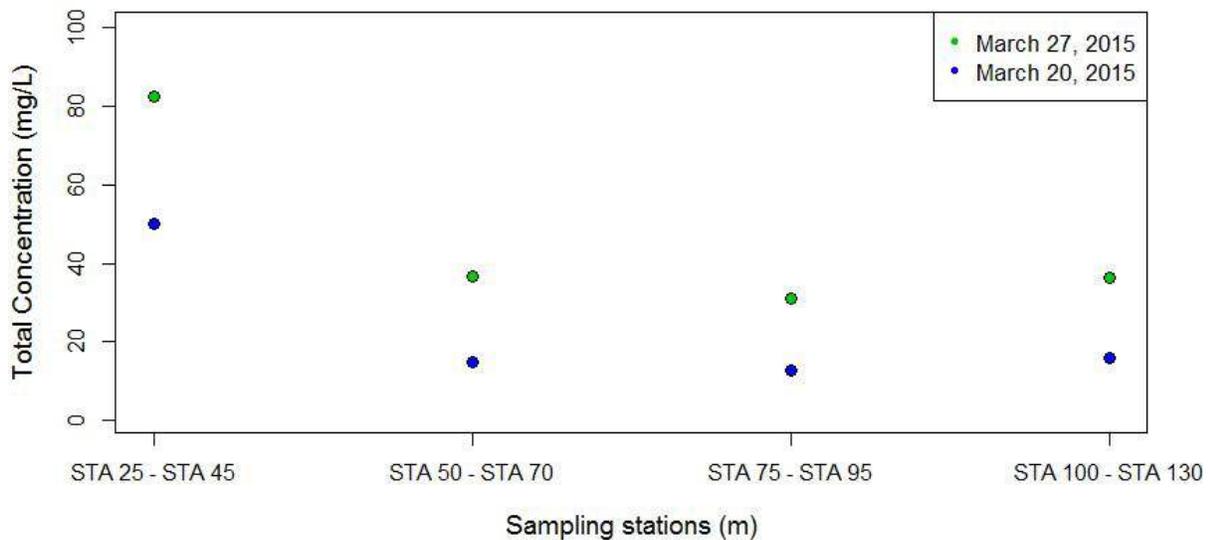
Figure 13 Cross-channel variation in suspended sediment concentration.

Cross-channel variation in sediment concentration confirms that Murray Creek significantly influences mainstem Nechako concentration for approximately 20 m nearest to the left bank. On March 20th and 27th, 2015, this 20 m section of the Nechako produced sample concentrations that were respectively 3.4 and 2.4 times greater than the average concentration across the remaining channel distance (Figure 13). Total channel concentration on these dates decreased respectively by 25.6% and 15.6% when the affected 20 m section was omitted from the analysis (Table 3).

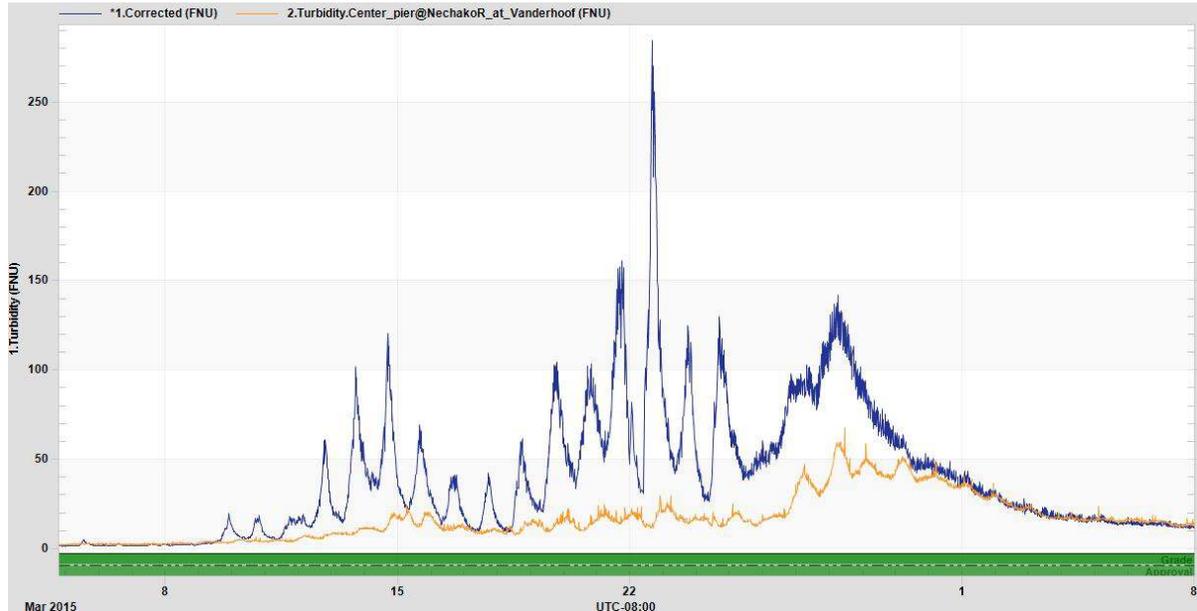
Figure 14 Daily turbidity pulses during 2015 freshet. Left Bank sensor shown in blue, Center Pier sensor shown in orange.

The Center Pier turbidity sensor provided data that was less influenced by Murray Creek and therefore more indicative of the mainstem Nechako conditions. Comparison between both sensors indicates that mainstem turbidity reached only a fraction of left bank turbidity values, with a maximum peak turbidity of 68 FNU (Figure 14). The Center Pier data also shows a prolonged turbidity pulse throughout the month of June as a result of the high water conditions (Figure 15).

The turbidity time-series provided by the Left Bank and Center Pier turbidity sensors indicate the turbidity pulse from Murray Creek freshet occurs earlier, is more cyclic and has a much higher concentration than Nechako freshet (Figure 14). These findings are what would be expected for a smaller tributary system. However, no clear cross-channel trend was found in relative grain size concentration during the period when Murray Creek was heavily influencing overall concentration. A greater proportion of very fine sediment may have been expected within the Murray Creek affected section, but we found no evidence of this.

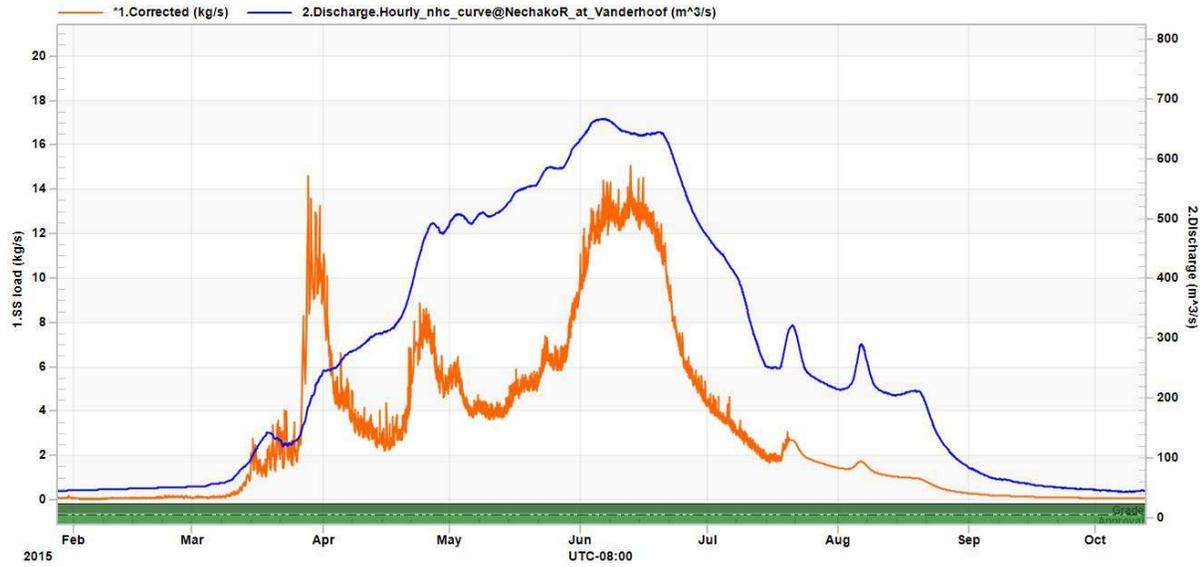
Figure 15 Suspended sediment load derived using Center Pier rating curve plotted against discharge. Sediment load is shown in orange, discharge in blue.

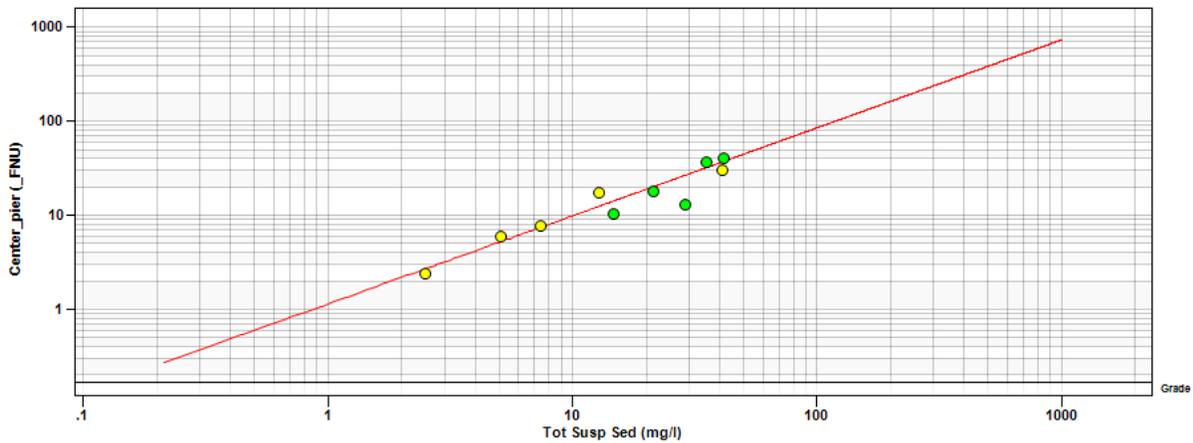
Figure 16 Suspended sediment-turbidity rating curve for the mainstem Nechako (Center Pier). Green points indicate adjusted values to exclude the influence of Murray Creek.

Separate suspended sediment-turbidity rating curves were developed from Left Bank and Center Pier sensor data. For the Center Pier curve, sampled sediment concentrations were adjusted to exclude the influence of Murray Creek by reducing the total channel-wide concentration by 20% (Table 3). This correction was applied to data collected between March 20th and March 29th based on field observations of a clear sediment plume extending downstream from the creek confluence. The adjusted concentrations plot in agreement with data collected throughout the rest of 2015 and was used to define the final rating curve for the mainstem Nechako (Figure 16). The relation between sampled sediment concentration and Left Bank turbidity showed greater scatter due to the rapid fluctuations of Murray Creek and the rating curve was defined simply as a best fit to the data (Figure 17). This curve was only used to generate the Left Bank sensor estimate of annual suspended load in Table 2.

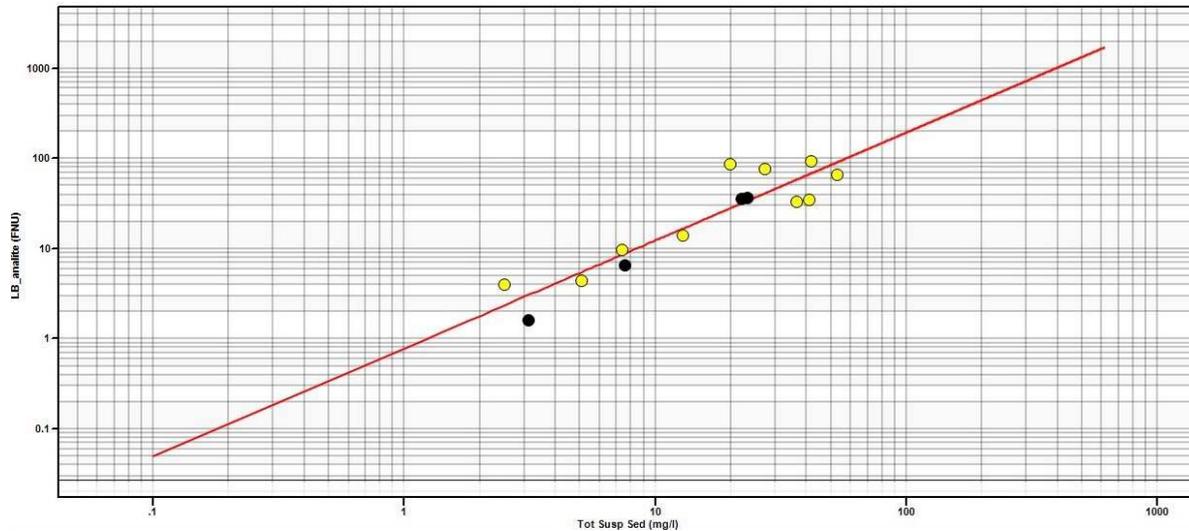
Figure 17 Suspended sediment-turbidity rating curve from the Left Bank sensor. Suspended sediment samples from 2015 shown in yellow, 2014 in black.

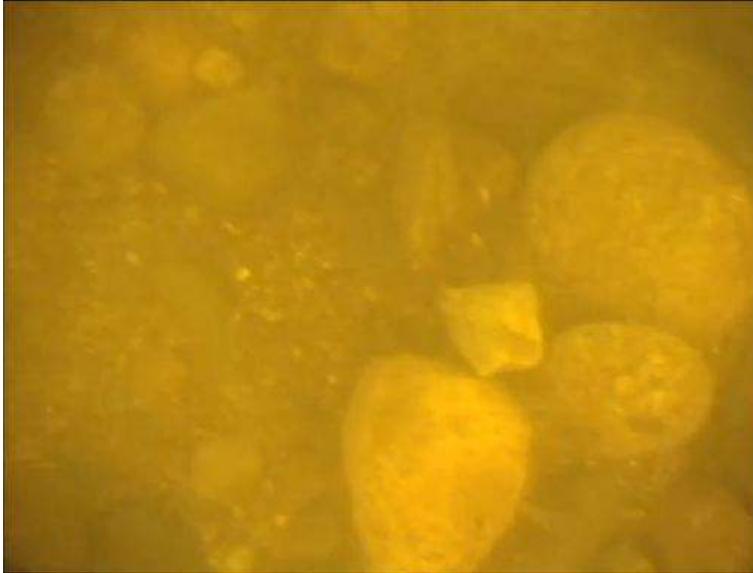
Photo 1 Substrate at site US 3.

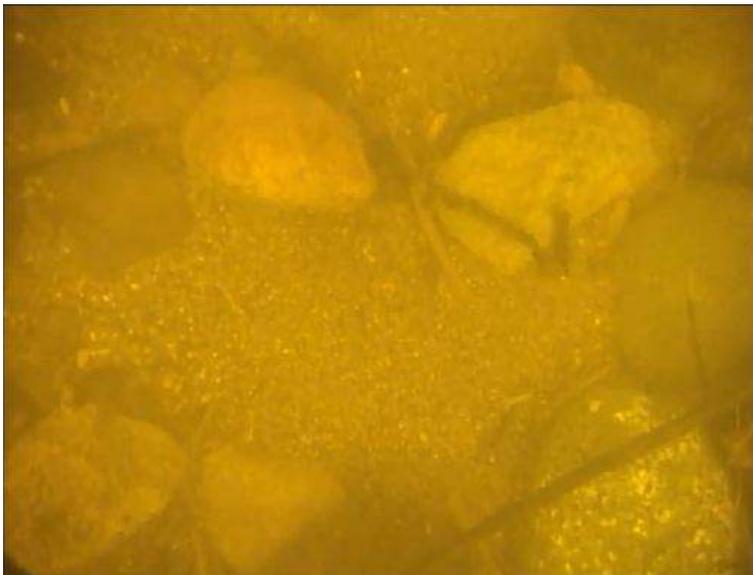
Photo 2 Substrate at site LP 3.

Images taken across the Lower Patch show a completely sand bed at site LP 1 located approximately 10 m from the left bank. Sites LP 2 through LP 6 extend roughly 60 m into the channel and show a bed composed of cobble and gravel with fine gravel and sand infilling interstices to varying degrees (Appendix C). The LP 3 site clearly shows placed spawning substrate with fine sediment deposited overtop (Photo 2), which is consistent with previously observed trends (NHC, 2013; NHC, 2014). Sites LP 2 to LP 6 correspond to the 40 m wide section with the highest bedload transport rates past this transect (Figure 11). The amount of fine sediment infilling coarser framework seems to decrease past site LP 6 until approximately 10 m from the right bank. Sites LP 8 and LP 9 in particular show a gravel bed relatively free of fines.

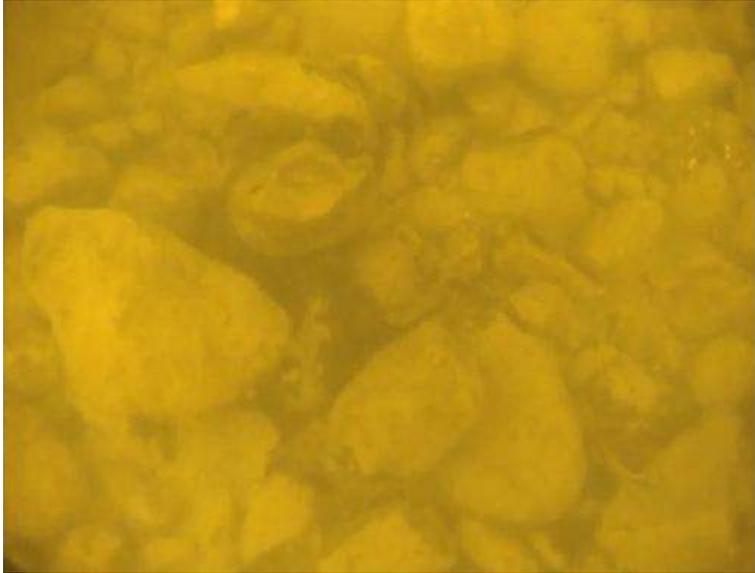
Photo 3 Substrate at site MP 2.

The placed spawning substrate at the Middle Patch remains generally free of fine sediment (Photo 3). However, a section of the Middle Patch near the confluence of Stoney Creek approximately 10 m upstream from site MP 1 (Map 1) did contain a significant amount of fine sediment deposited within the interstices and overtop the coarse framework. Site MP 3 located at the downstream most extent of the spawning pad also had a large proportion of fine sediment.

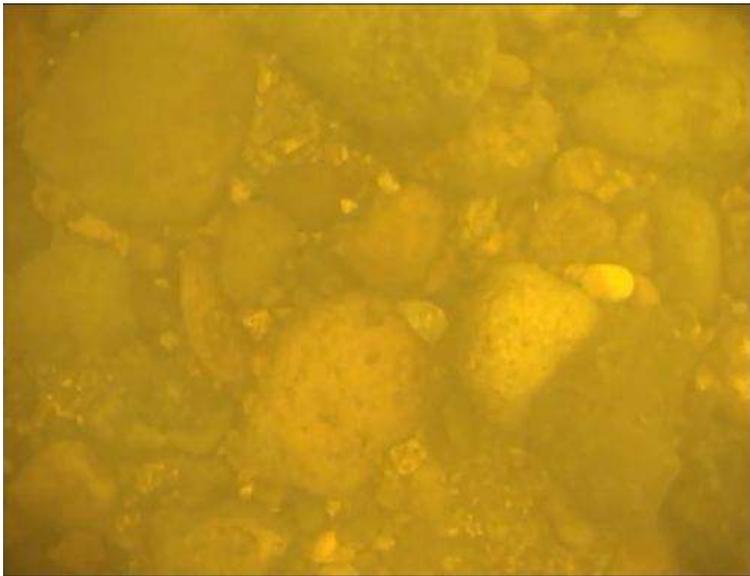
Photo 4 Exploratory site at 432340 E, 5986339 N.

Images were also taken for exploratory purposes within the first side-channel along the north bank immediately downstream of the Upper Site and at its confluence with the mainstem (Map 1). The northern half of this side-channel typically conveys the majority of incoming bedload that has been transported past the Upper Site, while the southern half typically conveys a smaller quantity of coarser bedload likely scoured from the island front. Site MU 5 (Map 1) is located in the high velocity, deep section nearest the southern bank and has a substrate composed of coarse gravel completely devoid of fine sediment (Appendix C). Photo 4 was taken where this side-channel re-enters the mainstem and shows a natural cobble and gravel bed containing a wide range of gravel sizes and a relatively low proportion of sand. This site is located in a deep area that provides a range of flow conditions including high velocity flow exiting the side-channel, low velocity flow behind the island and turbulent flow along the current seam. The location of Photo 4 is labeled as “Exploratory Site” in Map 1.

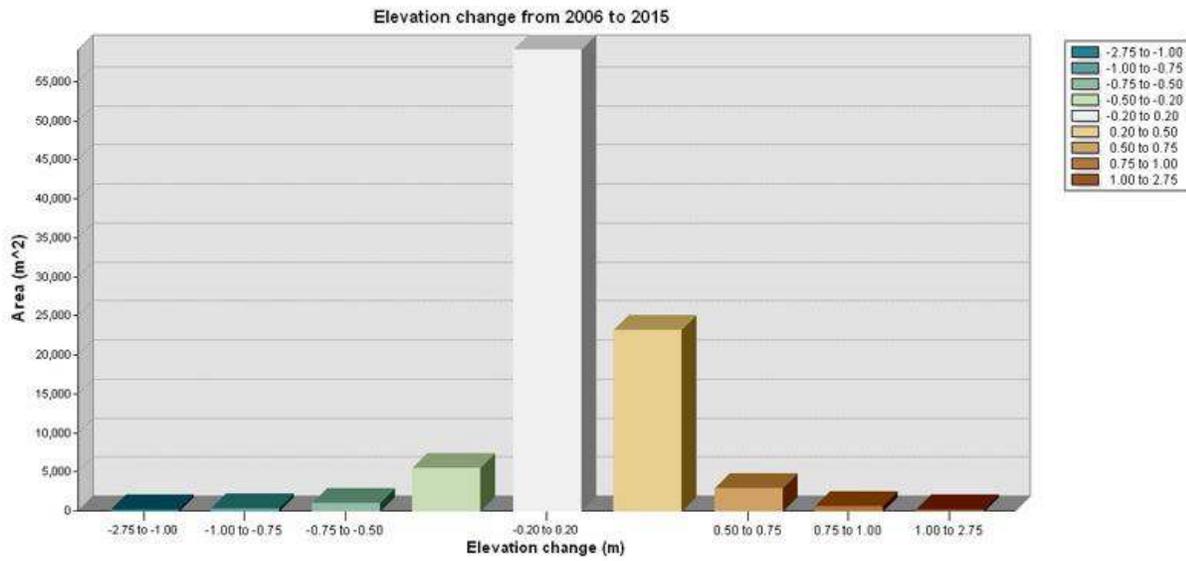
Figure 18 Classified elevation change from 2006/07 to 2015.

Figure 18 indicates the majority of elevation change was minor deposition in the 0.2-0.5 m range. This range of aggradation occurred over 25% of the total reach area. The total aggraded and degraded areas represent 29% and 7% of the reach respectively, with 64% showing no discernable change.

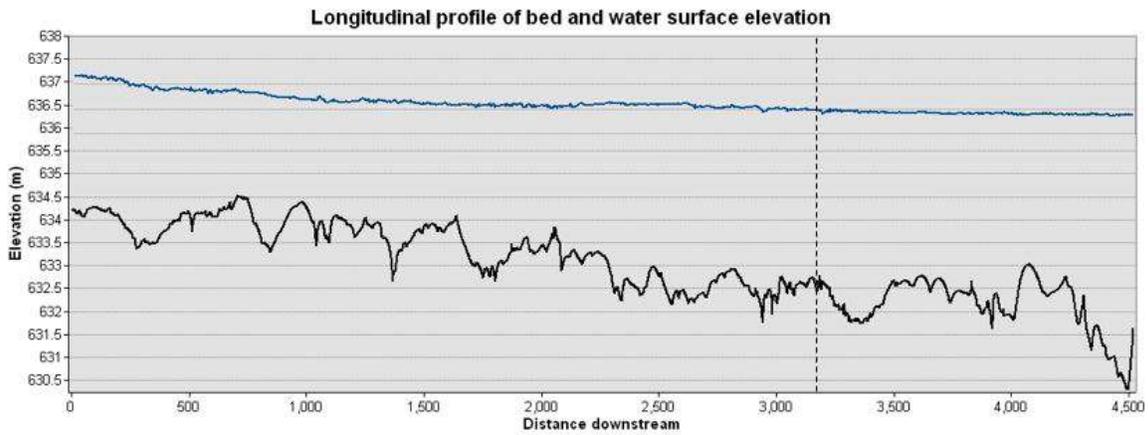
Figure 19 Longitudinal profile of the channel bed and water surface elevation within the spawning reach. The dashed line indicates the location of the Burrard Ave. Bridge.

A longitudinal profile of bed and water surface elevation was conducted along the main channel of the spawning reach. Figure 19 shows a steep water surface slope past the Upper Site (located on the figure at a downstream distance of 300 m) reflecting the high velocity flow through this narrow channel section. A clear non-uniform flow profile is seen upstream of the bridge where water surface slope decreases to zero due to the backwatered conditions. Backwatering is seen to extend about 1.5 km upstream from the bridge, which spatially corresponds to the reinforced section of right bank located about halfway between the confluence of Stoney Creek and the next westerly point.

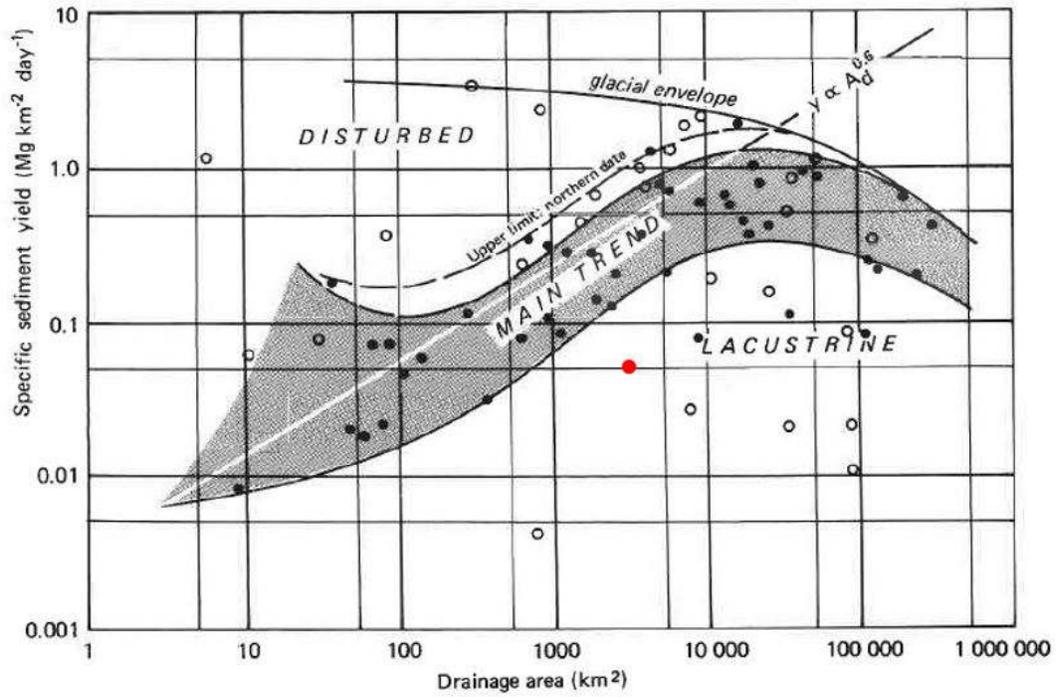
Figure 20 Suspended sediment yield for BC watersheds adapted from Church *et al.*, 1989. The Nechako basin is plotted in red.

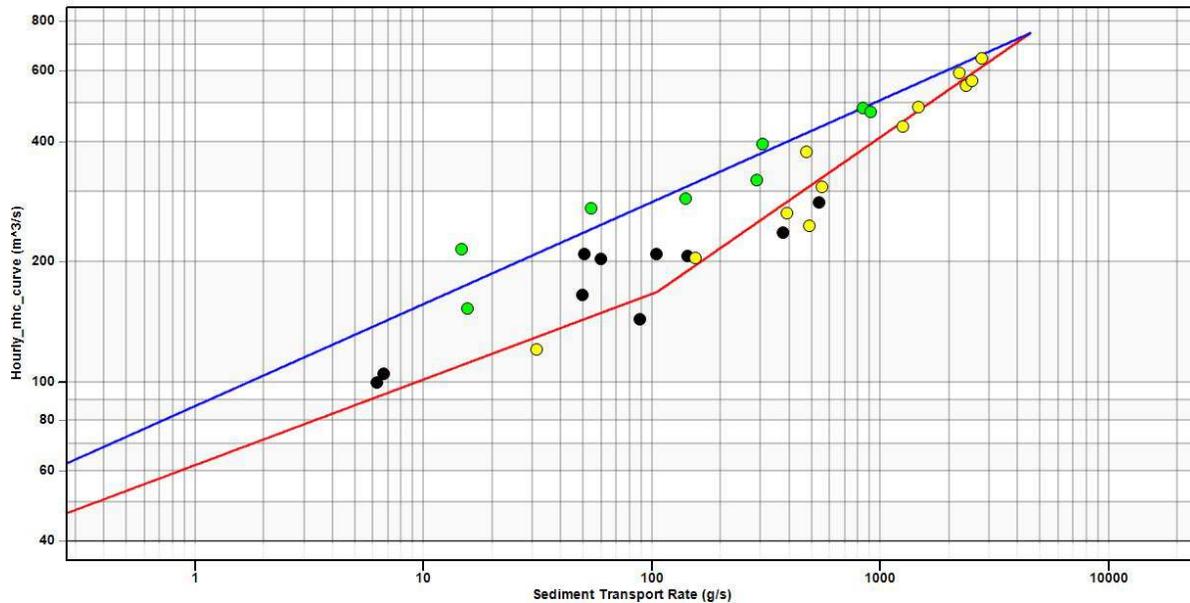
Figure 21 Figure 7 with April through August 2014 bedload transport shown in black.

Interestingly, hysteresis in the bedload transport rate suggests the availability of sediment within the active width of the channel became limited during the flood. The availability of bedload sediment likely decreased shortly after maximum wetted width and stream power were achieved as readily mobile material would have been moved as the flood waters were going up. Sediment supply may become limited fairly rapidly during peak flow since the bedload is largely sand, which can be entrained easily and transported in saltation at high velocity over considerable distances. The speed and distance of particle transport are important because bedload is often conveyed in a step-wise manner through stretches of river that link one depositional zone to the next; depositional zones being characterized by distinct reductions in channel gradient. Two such depositional reaches include the gradient break located approximately 35-45 km upstream of the spawning reach and the spawning reach itself (Figure 2 in NHC, 2013). Therefore, supply limitation at the Upper Site may have occurred because the duration of high flow was sufficient to transport sediment deposits through the river segment that links these two depositional areas. Years with less stream power do not show hysteresis and transport rates generally follow the capacity limited trend experienced during the rising limb of the 2015 hydrograph (Figure 21).

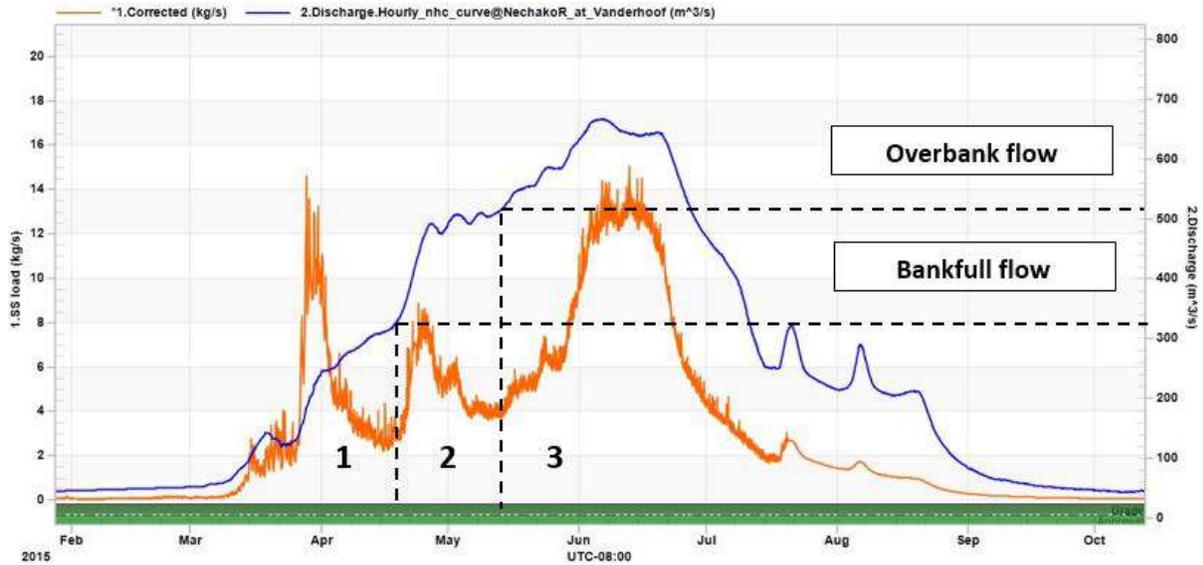
Figure 22 Modification of Error! Reference source not found. showing relation between sediment load and discharge.

The 2015 suspended sediment load was at least double the 2014 load despite having a relatively short freshet period. As seen in Figure 22, three periods of high transport seemed to have occurred throughout the year as flows began to access and mobilize sediment from different sources. The first pulse of sediment was transported during freshet and corresponds to the annual exogenous input from tributaries. This supply of fine sediment became exhausted soon after the tributary freshet was over resulting in a sharp drop in the transport rate. As discharge rapidly increased from about 320 m³/s to 500 m³/s, bankfull flow began to access new endogenous sources of sediment in areas that are not annually wetted including along the upper part of cut banks, bar tops and from low-lying vegetated islands. When discharge began to stabilize around 520 m³/s, the supply of suspended sediment once again became exhausted causing transport rate to decrease until the next increase in flow. The majority of the annual suspended sediment load was transported during the third period when peak flow and overbank conditions were reached. As discharge rose from 520 m³/s to 675 m³/s, sediment being supplied to the channel originated from both endogenous and exogenous sources including from the erosion of terrace scarps and the mobilization of within-channel and floodplain sediment deposits. Transport towards the end of this period rapidly declined as flows began to recede back into the previously wetted channel and were no longer accessing new sources of sediment.
