2015 SEDIMENT TRANSPORT INVESTIGATION ON THE VANDERHOOF REACH OF THE NECHAKO RIVER

FINAL REPORT

NHC Ref. No. 3000854

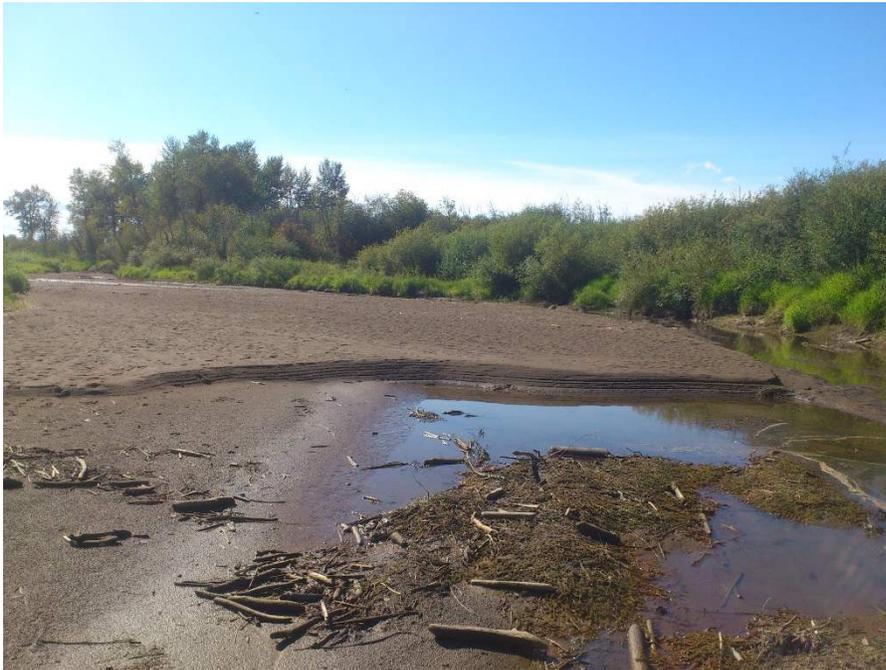
Photo 5 Advancing dune deposited within side-channel as flow receded (looking upstream).

As previously mentioned, geomorphic changes detected by differencing the high-resolution 2015 DEM from the previous 2006/07 DEM (NHC, 2008) are highly uncertain and additional analysis is required to assess the significance of results. Nonetheless, deposition within the northern most side-channel immediately upstream of the Lower Patch (Map 3) is likely true and is consistent with observations made this year of large advancing sand dunes in the area (Photo 5). A fairly marked gravel-sand transition located near the upstream most extent of backwatering also corroborates this trend. The largest dunes observed this year had a 0.5 m high advancing face and were located just upstream of this small side-

channel, well within the backwatered portion of the reach. Deposition at the confluence of Murray Creek is also likely to be true and is supported by good data coverage and field observation. This area appears to be a depositional zone for both Murray Creek and Nechako bedload and can be clearly seen on the 2015 DEM (Map 2). A high resolution survey of this deposit was done in October 2015 to establish baseline data needed to determine the rate of fan growth should repeat surveys be conducted in the future.

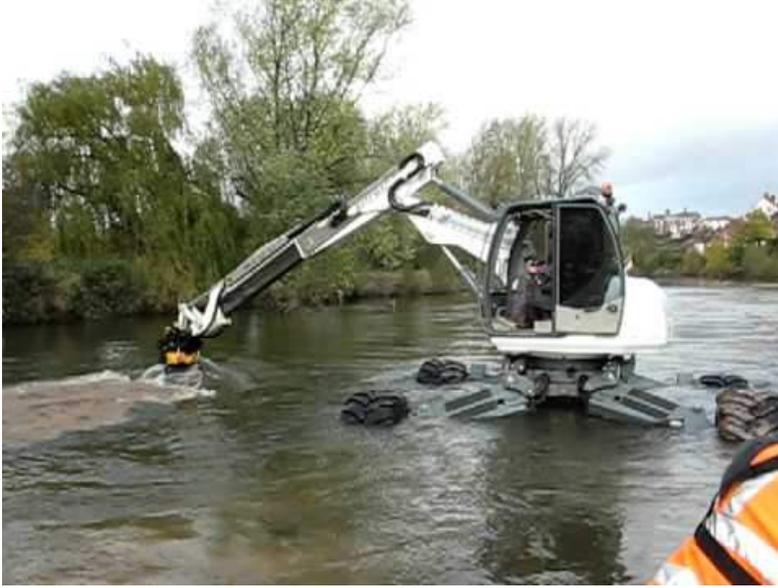
Figure 23 Example of a walking excavator used for in-channel site restoration.

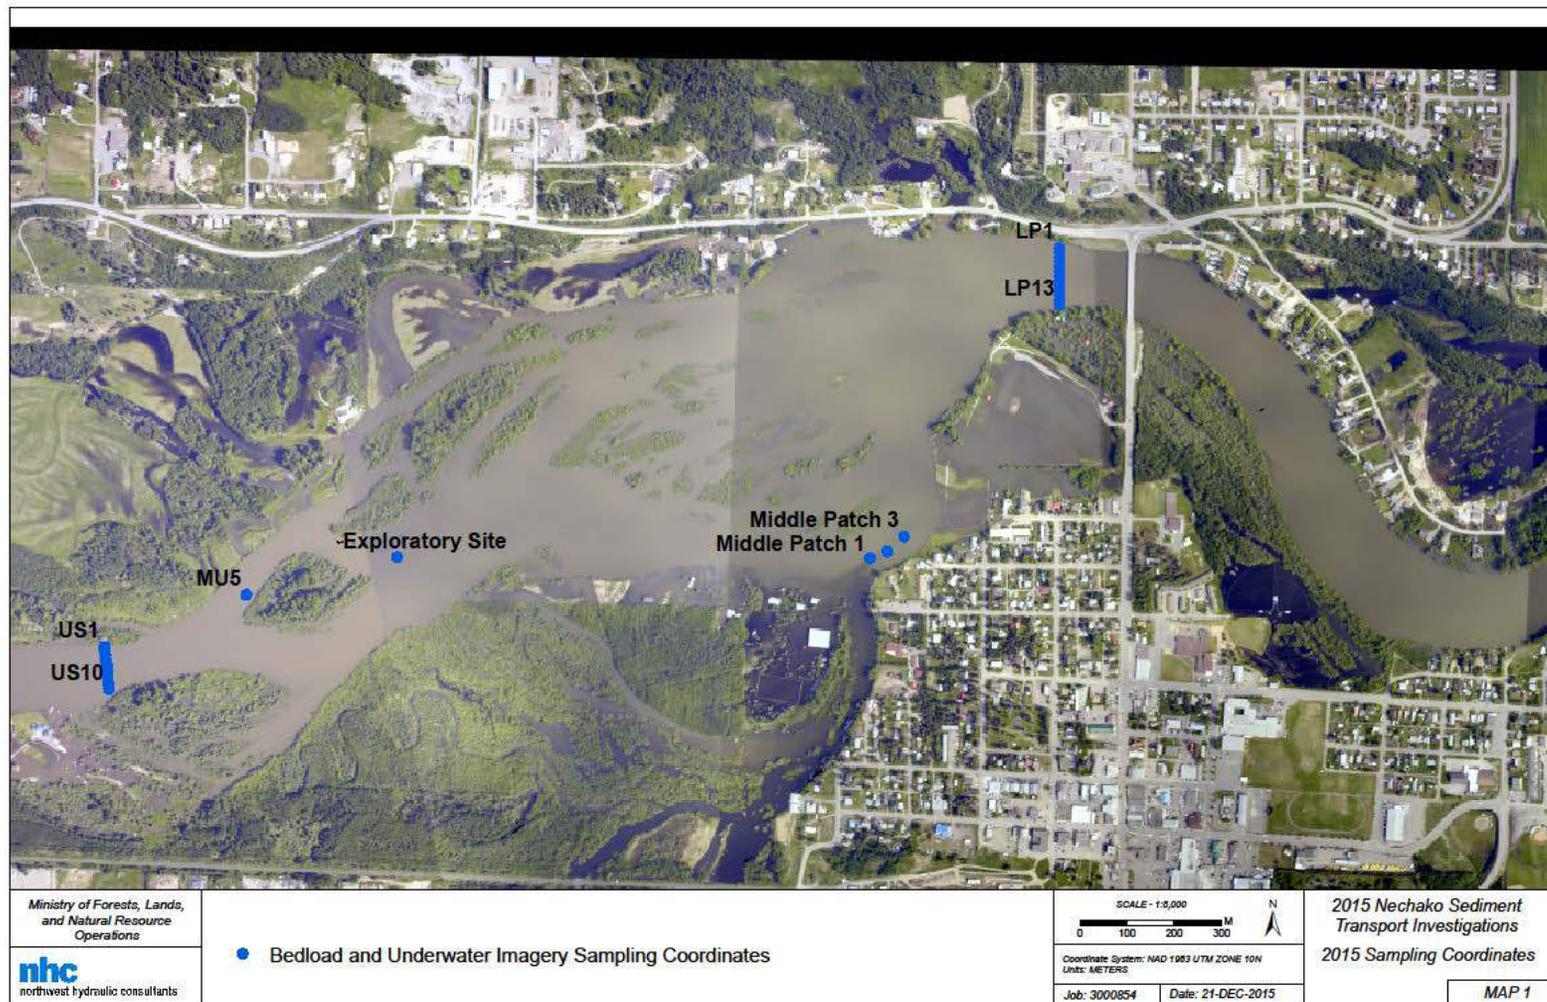
Map 1 2015 bedload and underwater imagery sampling locations

Bedload transport was sampled across the Upper Site and Lower Patch transects at evenly spaced intervals spanning the entire channel width (Map 1). The detailed sampling program is provided in previous reports (NHC, 2015) and 2015 bedload data is summarized in Appendix A.

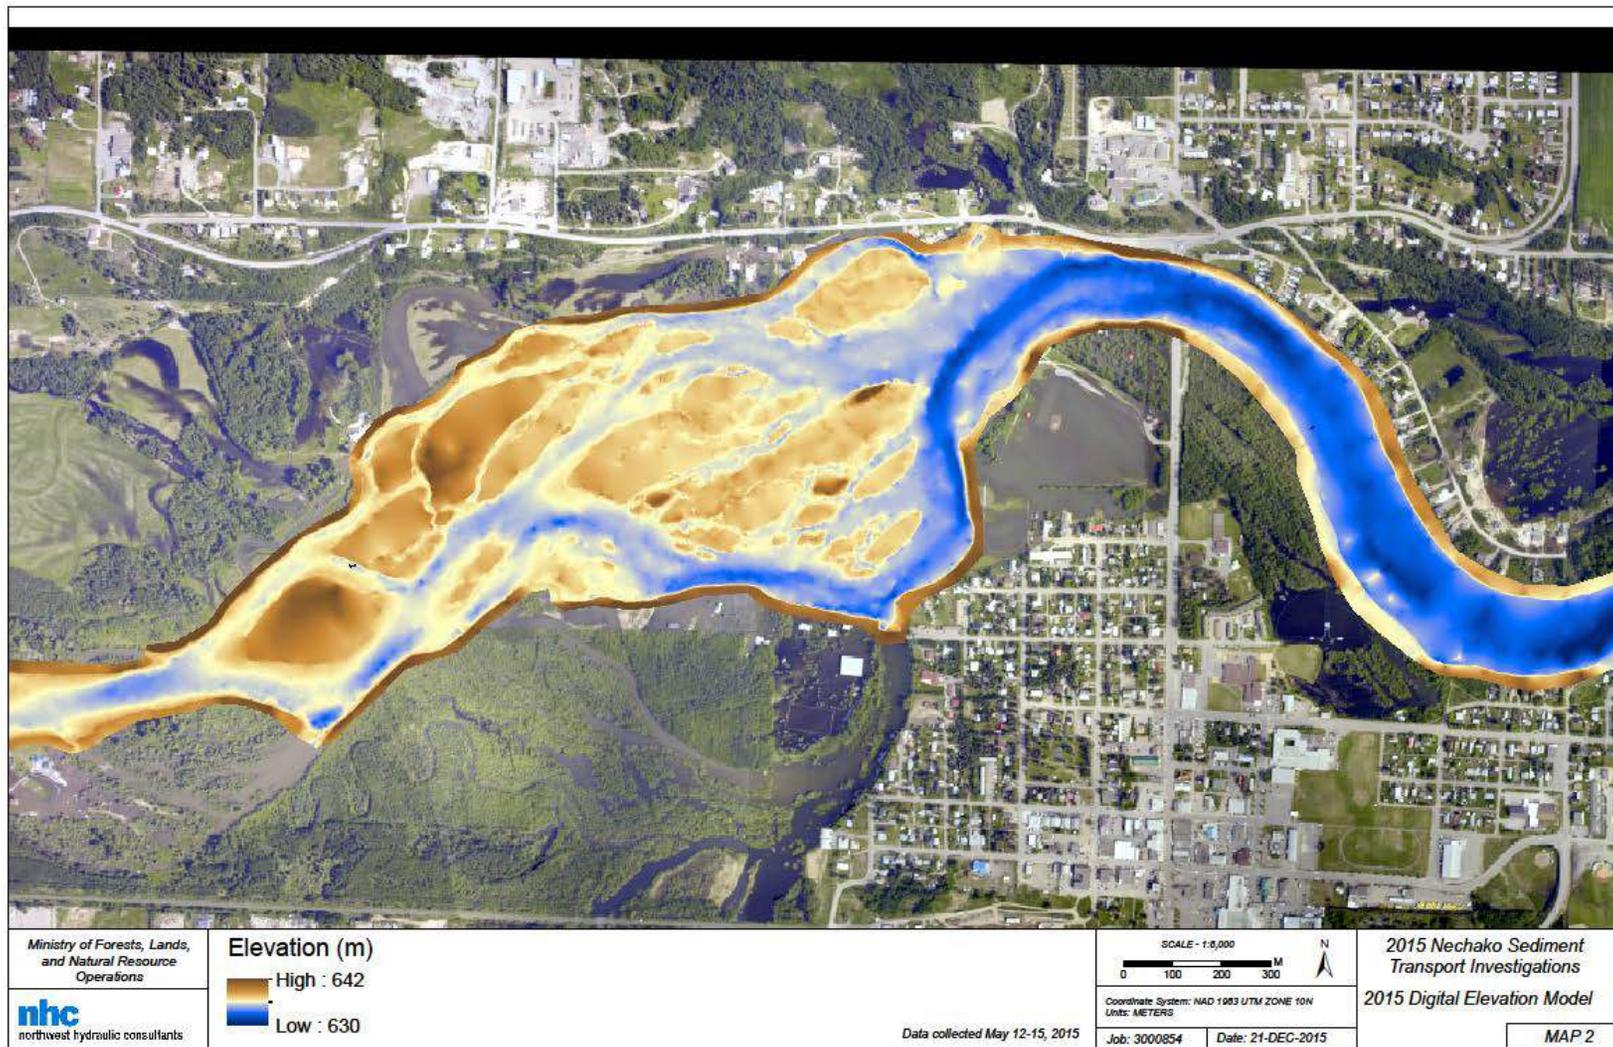
Map 2 2015 Digital Elevation Model

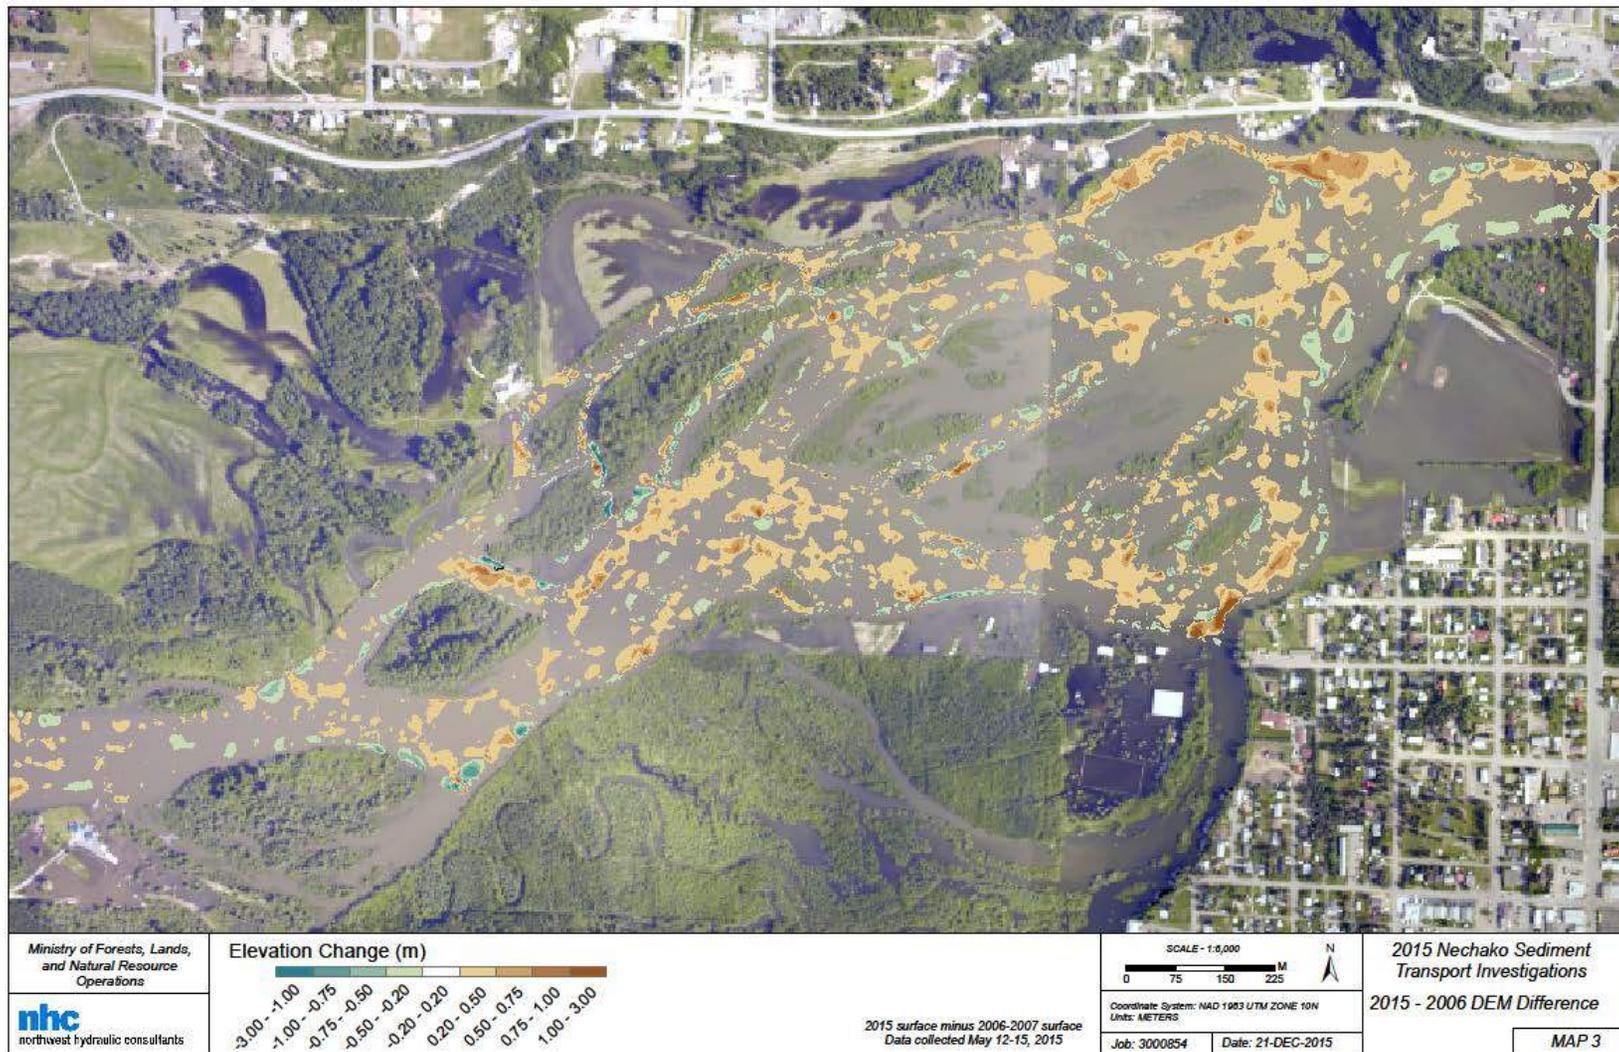
Map 3 Elevation change from 2006/07 to 2015

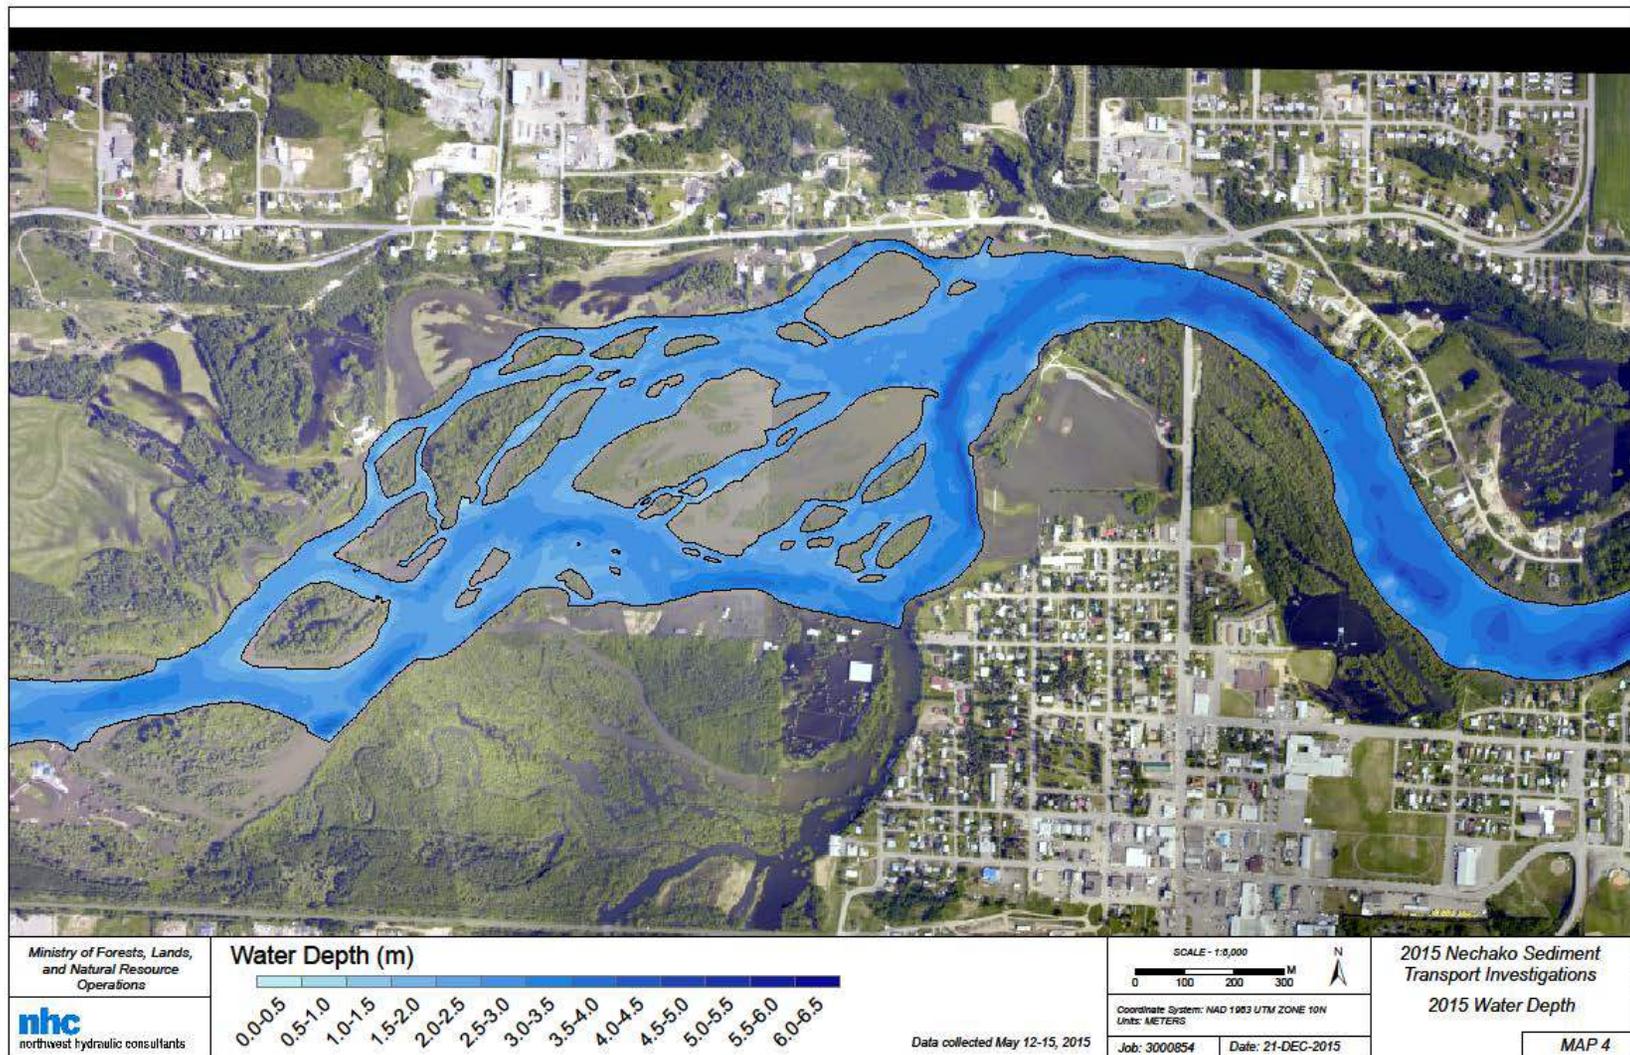
Map 4 Water depth during discharge of approximately 525 m³/s. Overbank flow depths not shown.

Maps 3 and 4 suggest that complex habitat in a wide range of hydraulic conditions was available within the reach during the 2015 spawning season. Relatively deep pools were located in both high velocity and low velocity sections of the river with very different turbulence intensities. Pools were also present in areas of flow convergence such as channel constrictions and side-channel confluences. However, the deepest pools remained downstream of the island complex within the single-thread channel and were over 6.5 m deep during the spawning period.
