**2016 Spawning Substrate
Restoration on the Nechako River
at Vanderhoof, BC**

**Ministry of Forests, Lands and
Natural Resource Operations
2000 South Ospika Blvd
Prince George, BC
V2N 4W5**

FINAL REPORT

**19 May 2017
NHC Ref. No. 3001725**

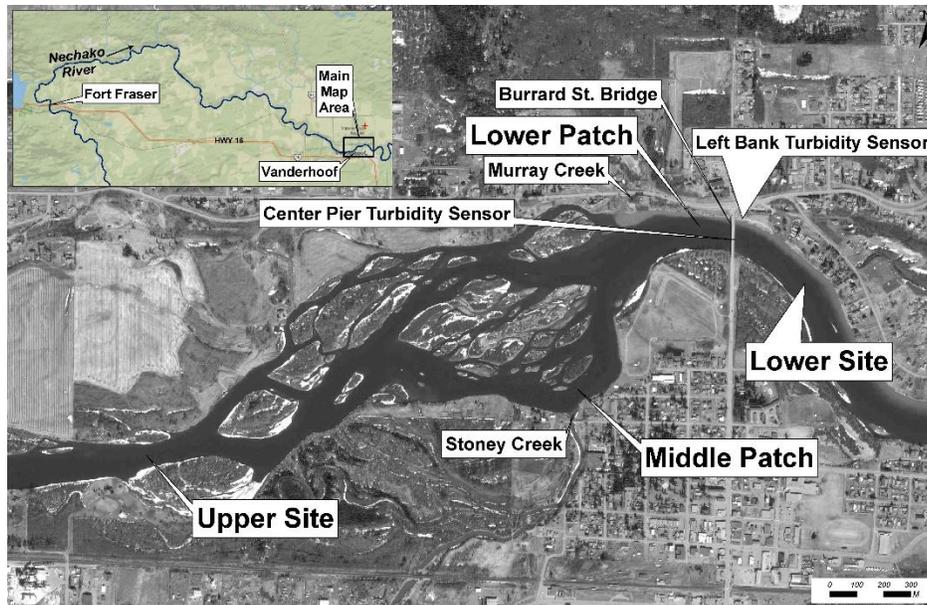
Figure 1 Nechako River at Vanderhoof, BC. The 2016 Substrate Cleaning operation was conducted at the Lower Patch.

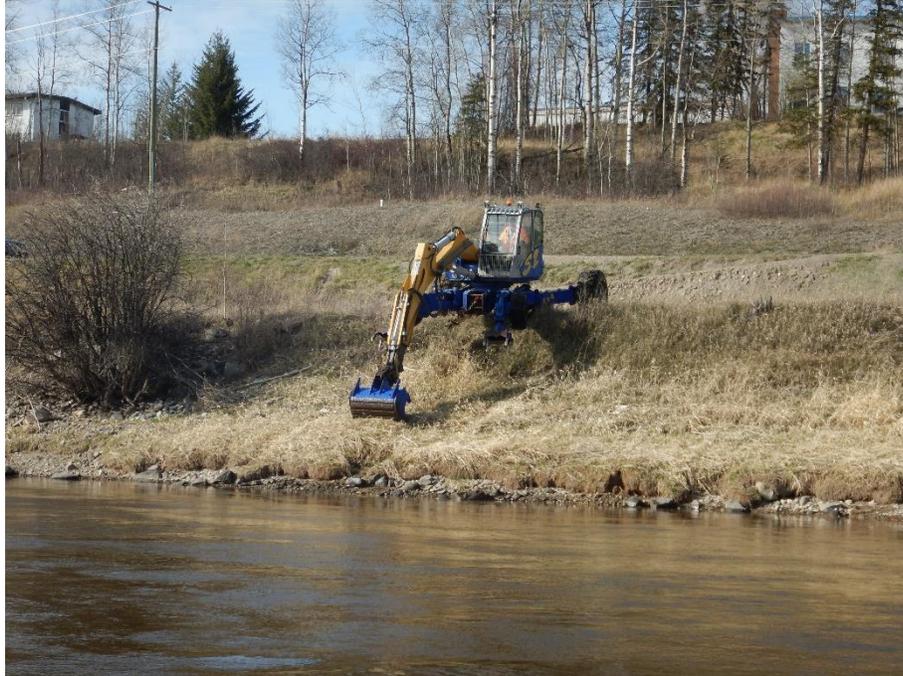
Figure 2 S2-3 Kaiser 4x4 Spyder Walking Excavator accessing the Lower Patch directly from the north bank.

Given the site-specific context and goals of the Nechako Sediment Cleaning operation, mechanical remediation using an S2-3 Kaiser 4x4 Spyder Walking Excavator (Figure 2) was selected as the most effective and efficient restorative measure (NHC, 2016). This method, similar to the Qualicum method described above, uses the excavator to rake, scarify and sift the cobble bed using a large 1.5 m-wide toothed bucket (Figure 3). Reasons which led to the selection of this method included its efficiency in removing infilled fines from the surface and subsurface layer, high instream maneuverability, ability to work in relatively deep and fast-flowing water, ability to move over wide areas, ability to access the Lower Patch with low impact and its lower cost and higher productivity relative to hydraulic dredging methods. That said, one major drawback of this mechanical cleaning method is that fine sediment is not actually removed from the system but is suspended into the water column, transported and eventually deposited downstream. Given that the substrate downstream of the Lower Patch is already composed largely of sand and silt, the suspension and resettling of fines was considered to have negligible impact on the overall habitat quality and substrate composition downstream.

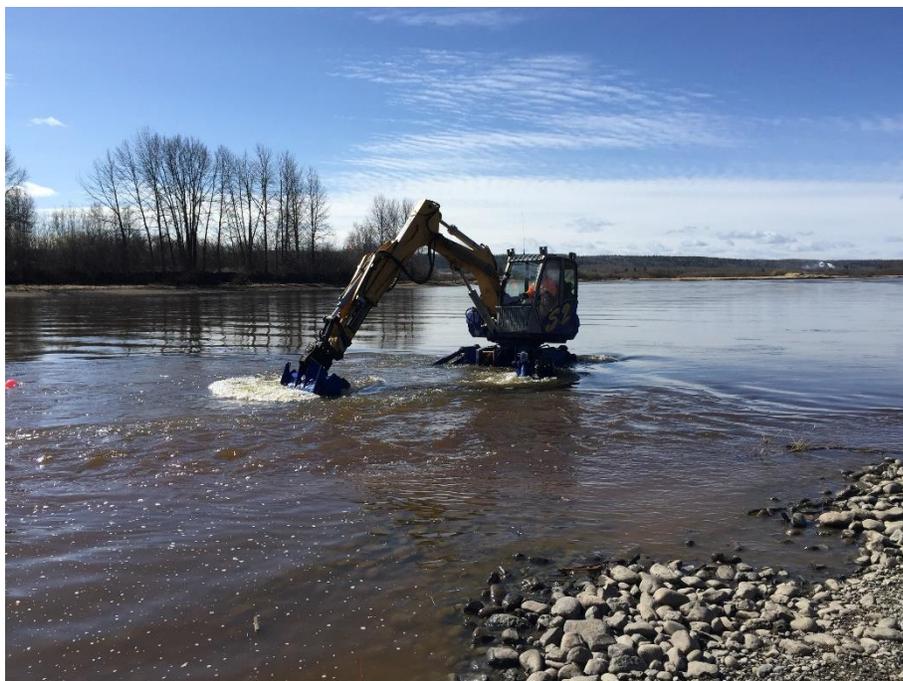
Figure 3 Excavator with 1.5 m-wide toothed bucket raking and sifting the cobble/gravel bed at the Lower Patch (placed substrate seen along bank).

To sift, rake and scarify the substrate, the excavator would use its bucket to repeatedly dig and shake-out the substrate, thereby bringing fine sediment into suspension and allowing the coarsest material to re-deposit in place. The excavator bucket was approximately 1.5 m in width by 1 m in length and could therefore treat roughly 1.5 m² of the bed per bucket placement. The operator maintained a relatively constant digging depth of approximately 30 cm, which he would increase if there was a lack of cobble/gravel in the bucket indicative of a very thick sand deposit overtop the placed substrate. This process was repeated until minimal fines were observed by the operator in the bucket, at which point the excavator would progress along the transect. A handheld Garmin GPS unit was used to track the excavator’s movement because the machine was not equipped with any positioning device.

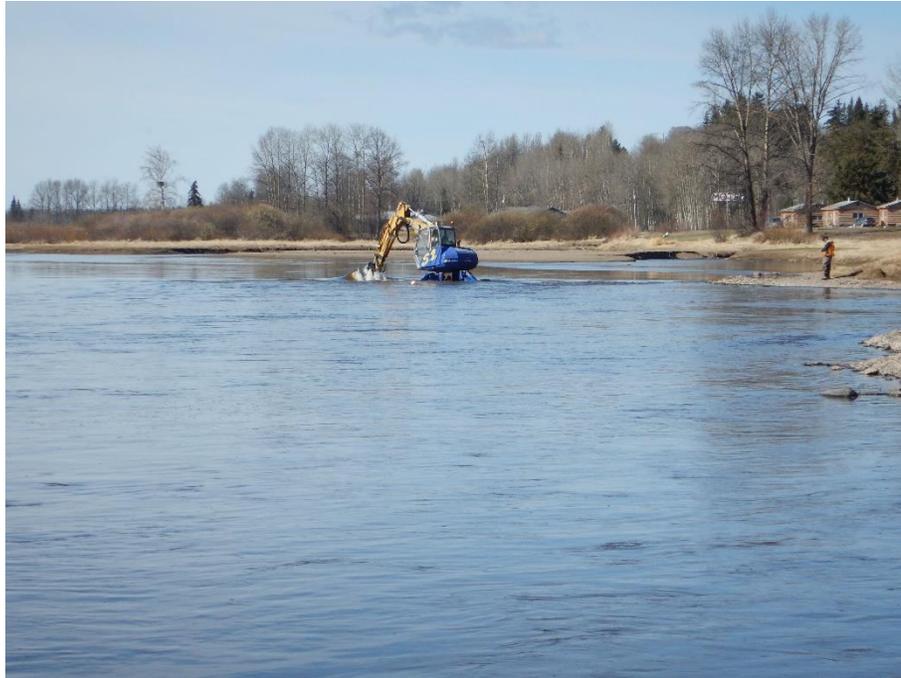
Figure 4 Excavator beginning the remedial work at the upstream extent of the Lower Patch.

The S2-3 Kaiser 4x4 Spyder Walking Excavator was operated by Len Masson, owner of Nu Creek Developments Ltd. The excavator was mobilized in the town of Vanderhoof and then driven directly across the Burrard Ave. Bridge and down the north bank of the river to access the Lower Patch. The remediation work began at the upstream most extent of the Lower Patch and gradually progressed downstream (Figure 4). The excavator generally worked from the mid-channel towards the bank along transects spaced roughly equal to the excavator’s reach. Transect locations were not pre-determined and relied on the operator’s experience and visual aids placed along the bank. The operation began on April 6th, 2016 at approximately 11:45, and was completed by around 13:00 on April 7th, 2016.

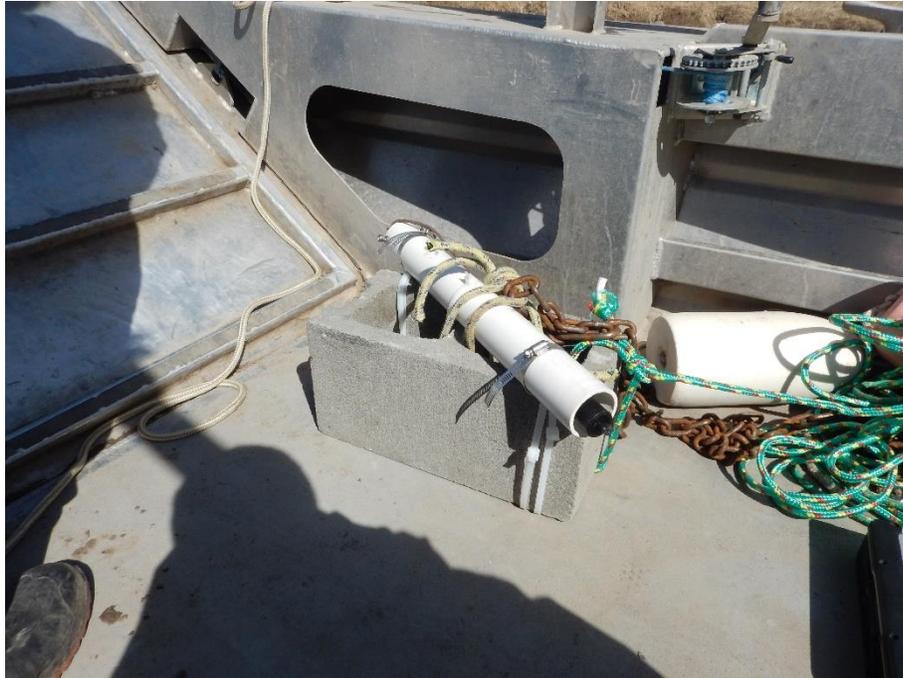
Figure 5 Standalone turbidity sensor installed downstream of the remedial work.

Turbidity was continuously monitored during the operation by two Analite® turbidity sensors positioned downstream of the Lower Patch. The first sensor, previously installed on the south side of the middle bridge pier (NHC, 2016), has been transmitting data continuously since October 20th, 2014. The second sensor was a standalone unit, deployed specifically to measure the turbidity of the sediment plume caused by the remedial work and to assess potential downstream impacts. This standalone unit was fixed to a cinder block roughly 20 cm above the river bed and oriented obliquely downstream to prevent fouling of the signal caused by the accumulation of debris on the sensor (Figure 5). It was positioned directly downstream of the area to be cleaned (Map 1) and was initialized on April 6th, 2016 at 12:09, roughly 15 minutes after the start of the instream works. On April 7th, this sensor was repositioned several meters towards the north bank according to the excavator's progress to capture the highest turbidity located directly in the sediment plume. The sensor continuously logged data until it was removed at 17:32 on April 8th, 2016, one day after the instream work had ceased.

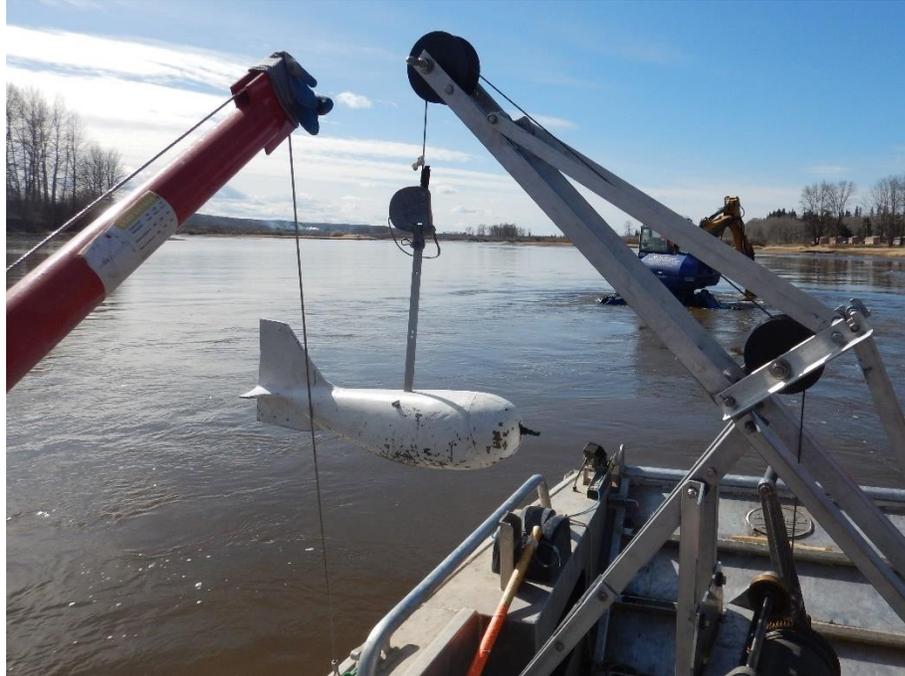
Figure 6 Sampling suspended sediment with the D-74 sampler downstream of the excavator.

Sampling was conducted from a boat provided by the Nechako White Sturgeon Conservation Center (NWSCC) using a D-74 depth integrated sampler lowered from a Bridge Crane to control the rate of descent (Figure 6). The D-74 sampler was used with a ¼" nozzle attachment and samples were collected with a target transit rate of 0.1 m/s. Samples were subsequently sieved at the UBC Geography lab.

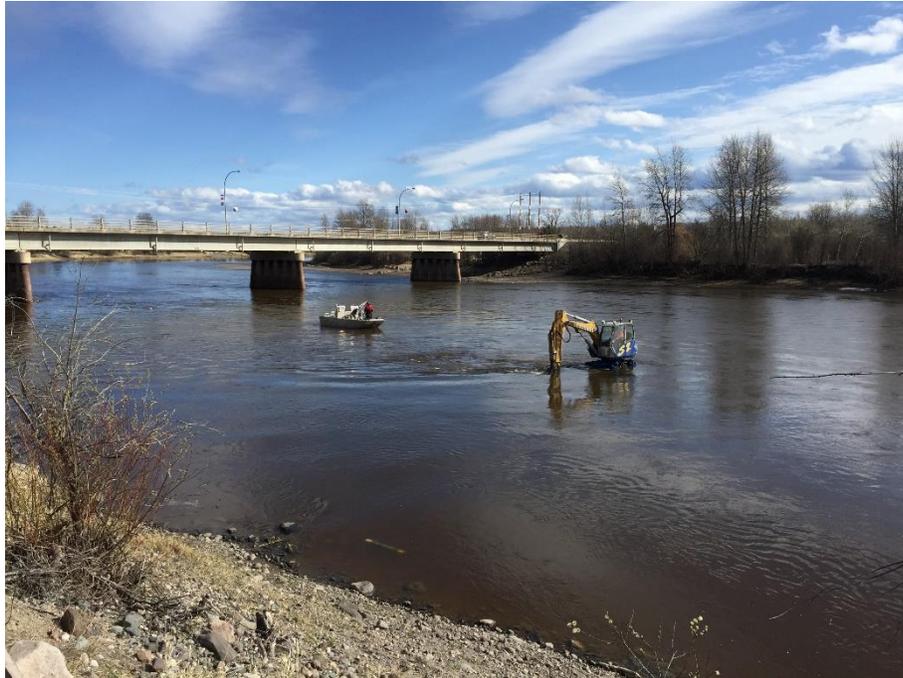
Figure 7 Sampling bedload sediment transport directly downstream of excavator.

Sampling was conducted from the NWSCC boat using a Helley-Smith sampler with a 76.2 mm wide opening and 0.125 mm mesh bag. Due to the low sediment transport rates initially sampled, nearly all samples were collected over a duration of 10 minutes. To deploy the sampler, the boat was held in place using an anchor and the sampler was slowly lowered onto the bed. The rope was left slack and monitored to ensure there was no risk of the sampler being dragged due to lateral boat movement. All bedload samples were sieved at the UBC Geography lab using $\frac{1}{2}$ phi sieves. For the purposes of this report, grain size classification is based on the length of the b-axis, or the intermediate axis perpendicular to the longest axis. Grain size texture is defined using the Wentworth scale in Table 2.

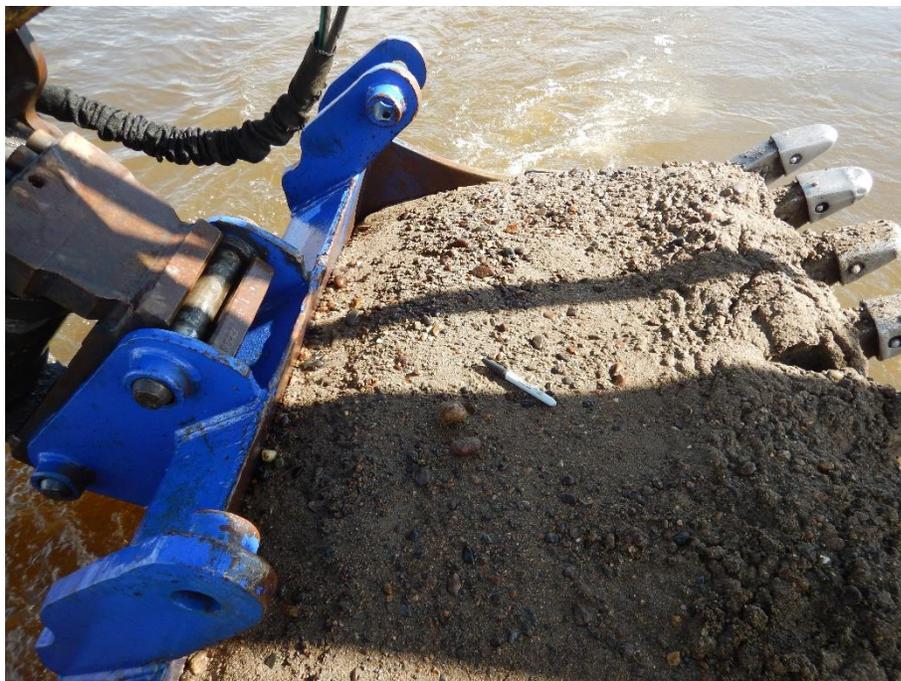
The substrate at the exploratory site, located approximately 550 m downstream of the Burrard Ave. Bridge along the south bank of the river, lacked a coarse size fraction and therefore did not warrant any further cleaning effort (Figure 8).

Figure 8 Substrate at the exploratory site lacking a coarse size fraction.

The trial remediation of the exploratory site located about 550 m downstream of the Burrard Ave. Bridge along the south bank provided further insight into the limitations of using mechanical remediation within the Nechako white sturgeon spawning reach. Although close to known spawning locations, this site did not warrant any cleaning effort because the substrate lacked a coarse size fraction and was dominantly composed of coarse sand and fine gravel. Judging by the trial remediation of this site and from previous work (NHC, 2014) that identified a similar substrate composition to be present downstream of the Burrard Ave. Bridge, mechanical remediation within the spawning reach is likely limited to the areas with placed cobble/gravel substrate or in areas upstream of the Lower Patch comprising coarse native substrate.

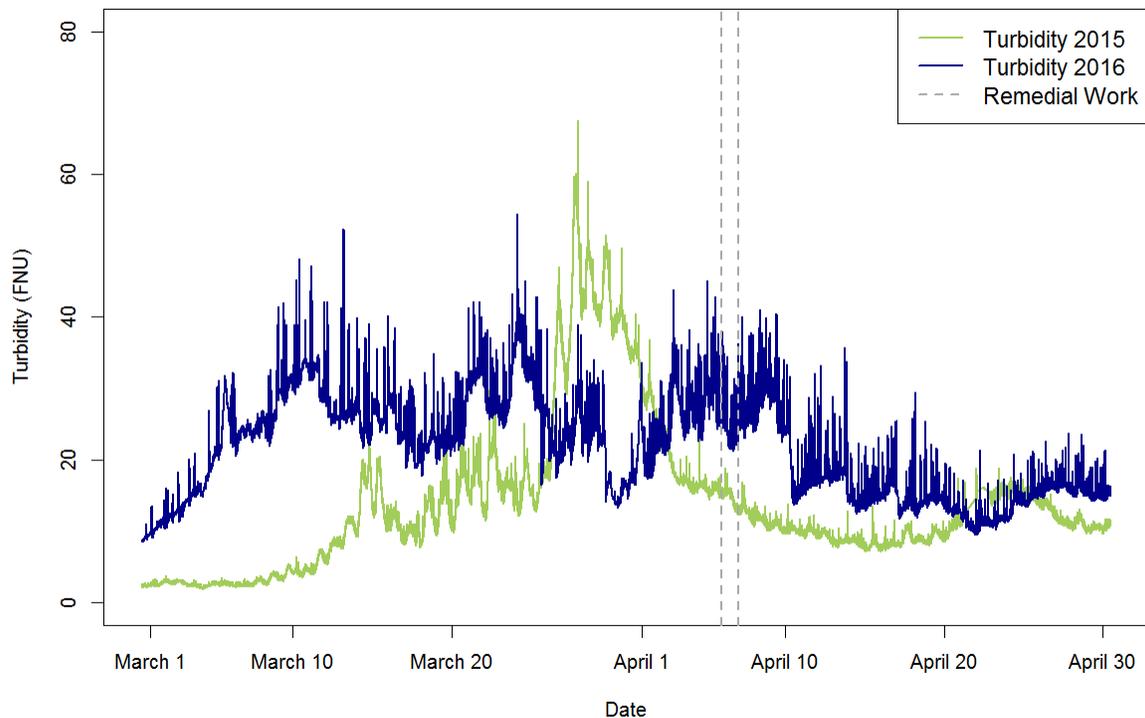
The background turbidity of the Nechako River during the remedial work period was relatively high compared to previous years. Seen in Figure 9, the turbidity pulse associated with freshet was of lesser magnitude in 2016 than in 2015, but was more prolonged. During the period spanning from April 1st to April 10th, the mean and maximum turbidity in 2015 was 17.8 FNU and 40.5 FNU respectively, while in 2016 the mean and maximum was 26.3 FNU and 45.1 FNU. It is important to note that during this period, the 2016 peak turbidity of 45.1 FNU was recorded on March 25th and was therefore unrelated to the instream operations.

Figure 9 Turbidity from the Center Pier sensor in 2015 and 2016.

Maximum turbidity in the Nechako River was lower in 2016 than in 2015, however the duration of the turbidity pulse associated with spring snowmelt and tributary freshet was longer (Figure 9). This may be because 2015 had more snowfall in January and February, followed by more rain in March which led to rapid melting of the snowpack. Comparatively, the 2016 freshet may have been more drawn-out in reason of the greater rainfall and higher temperatures experienced in April.

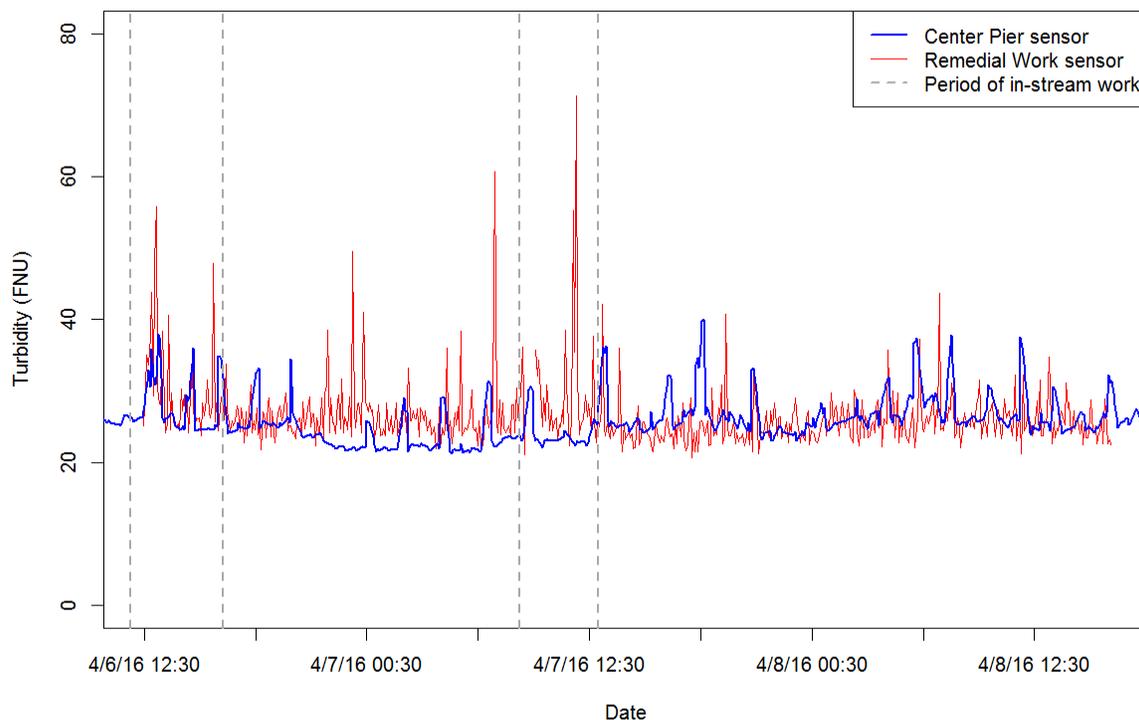
Over the course of the instream work, the average turbidity measured by the standalone sensor installed directly downstream of the restoration site was 26.5 FNU, which is only slightly more than the average turbidity of 25.9 FNU measured by the Center Pier sensor during this time. This, along with the rapid spikes in peak turbidity seen in Figure 10, suggest that the sediment plume caused by the instream work had a localized and temporary impact on the surrounding and downstream turbidity level. That said, the turbidity spikes measured by the standalone sensor provide a useful estimate of peak turbidity directly within the narrow plume.

The maximum turbidity caused by the operation was 71.3 FNU, recorded at 11:47 on April 7th, 2016 (Figure 10). This timing corresponds to when the excavator was working approximately 17 m directly upstream from the sensor. Again, the localized impact of the sediment plume is reflected by the 35.5 FNU and 31.9 FNU recorded 5 minutes before and after the peak, respectively. The next highest turbidity levels recorded on April 7th reached 55.3 FNU and 60.7 FNU, although the 60.7 FNU measurement was recorded at 7:24 prior to the commencement of instream work that day. On the first day of operations, when the excavator was working at the upstream extent of the Lower Patch approximately 140 m upstream of the sensor, maximum turbidity ranged from 47.9 FNU to 55.9 FNU.

Figure 10 Turbidity from the Center Pier and standalone sensors during the 2016 remedial work.

Although the relatively turbid water in early April 2016 was not ideal for the instream work because it reduced the visibility of the substrate, it did narrow the gap between the ambient Nechako turbidity level and the local, elevated turbidity plume caused by the excavator. The difference between the maximum turbidity that was recorded directly in the sediment plume and the ambient turbidity was about 45 FNU, however this magnitude of difference was only measured in very a localized spatial and temporal window. Once the distance downstream of the excavator had reached around 150 m, the maximum difference was reduced to about 30 FNU. The relatively rapid dilution of the sediment plume into already turbid water, along with the very short duration of measured turbidity spikes (Figure 10), suggests that the sediment plume caused by the instream work had a relatively localized and temporary impact on the surrounding and downstream turbidity level.

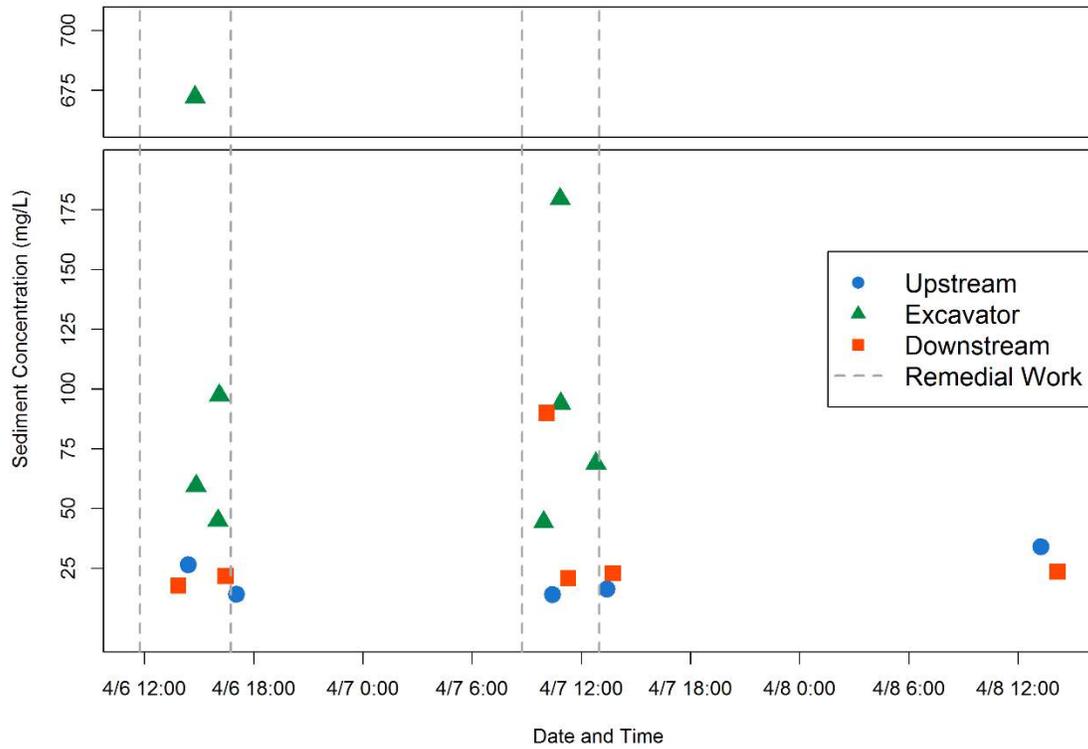
As expected, the highest suspended sediment concentrations were sampled immediately downstream of the excavator, while the lowest concentrations were sampled upstream of the operation (Figure 11). More specifically, the mean sampled sediment concentration was 21.1 mg/L upstream of the operation, 157.6 mg/L downstream of the excavator and 32.8 mg/L downstream of the Lower Patch. The same trend was observed in the grainsize of the suspended sediment, where the D_{90} grainsize was 0.3 mm upstream of the operation, 0.6 mm immediately downstream of the excavator and 0.4 mm downstream of the Lower Patch. Note, however, that the overall difference in D_{90} grainsize remains minimal.

Figure 11 Suspended sediment concentrations sampled during the period of remedial work.

Throughout the duration of the remedial work, suspended sediment concentrations at the upstream extent of the Lower Patch were relatively low and constant when compared to the other sampling locations (Figure 11). Consistency of these measurements supports that this location was effectively monitoring the background suspended sediment level within the mainstem Nechako, serving as a reference point for comparison with concentrations downstream of the operation. Overall, the trend in mean sediment concentrations suggests that the remedial work was effective in promoting the downstream transport of fine sediment, with mean concentrations of 21.1 mg/L upstream of the operation, 157.6 mg/L downstream of the excavator and 32.8 mg/L downstream of the Lower Patch.

As expected, the highest sediment concentrations were measured immediately downstream from the excavator. Although the maximum concentration sampled within the plume caused by the excavator reached a very high 672.1 mg/L, it would have likely declined rapidly downstream as larger grains settled out of suspension. This is supported by the peak concentration of 90.0 mg/L that was sampled at the downstream extent of the Lower Patch when the excavator was approximately 25 m upstream, assuming both samples had similar initial concentrations. This is further supported by the coarseness of the D_{90} grain size within this sample (0.95 mm) compared to the mean D_{90} downstream of the Lower Patch (0.4 mm). In fact, 59% of the sediment in this sample was coarser than 0.25 mm medium sand, with 14% being larger than 0.5 mm coarse sand. The size class of this material is consistent with sediment typically transported as bedload over the Lower Patch, infilling the cobble/gravel substrate (NHC, 2016). The rapid settling of this material out of suspension suggests that the remedial work must progress in fairly small downstream increments to effectively coarsen the substrate composition.

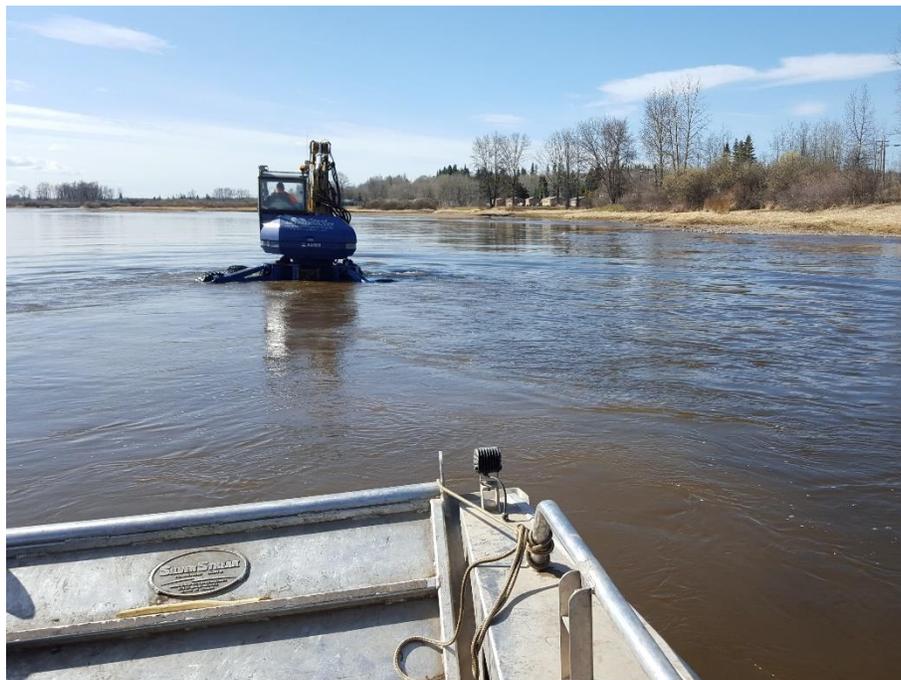
The highest suspended sediment concentration was 672.1 mg/L, sampled on April 6th, 2016 at 14:47 directly downstream of the excavator (Figure 12). This sample also had the coarsest D_{90} of all the samples, reaching 0.95 mm. The highest concentrations sampled at the upstream and downstream ends of the Lower Patch were 34.1 mg/L and 90.0 mg/L, respectively. The 90 mg/L sample was collected on the second day of operations when the instream work had progressed to approximately 25 m upstream of the sampling location.

Figure 12 Plume from where the highest concentration of suspended sediment was sampled.

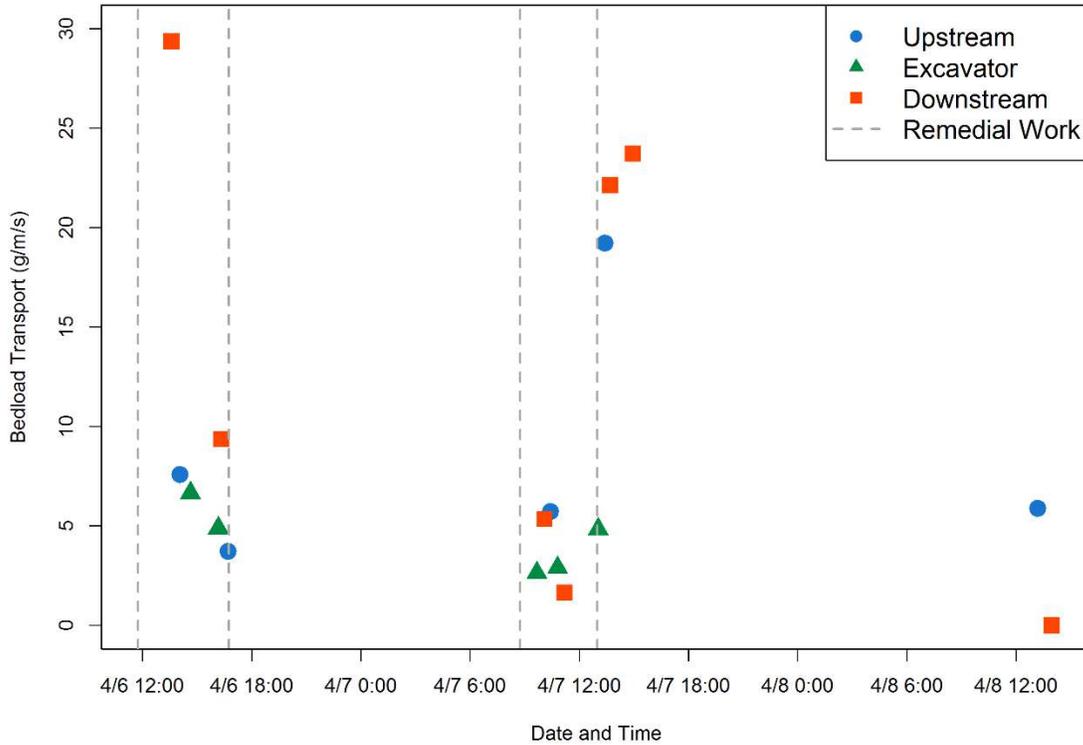
Contrary to the trend in suspended sediment, where the highest concentrations were measured directly downstream of the excavator, the highest bedload transport rates were sampled at the downstream extent of the Lower Patch (Figure 13). In fact, bedload transport immediately downstream of the excavator was relatively low. The mean transport rate downstream of the excavator was 4.4 g/m/s, compared to the mean transport rates upstream and downstream of the Lower Patch which were 8.4 g/m/s and 13.1 g/m/s, respectively. It is important to note, however, that it is difficult to draw clear conclusions regarding the efficacy of operations using the sampled transport rates due to the inherent variability of sediment transport and the limited number of samples that were collected.

The highest bedload transport rate, 29.4 g/m/s, was sampled downstream of the Lower Patch on April 6th, 2016 at 13:36. This timing corresponds to approximately 2 hours after the start of instream works, when the excavator was roughly 100 m upstream of the sample site. The next highest transport rates, of 22.1 g/m/s and 23.7 g/m/s, were also sampled at the downstream location, but on April 7th, 2016 at 13:42 and 14:57, respectively. This temporally corresponds to shortly after the instream work had been completed around 13:00, when the excavator had been working in the vicinity of the sample site. The amount of bedload being transported into the area from upstream remained relatively constant during the period of remedial work, varying between 3.7 g/m/s and 7.6 g/m/s, except for the one higher sampled rate of 19.2 g/m/s. The D_{84} grainsize of the bedload material at all sampling locations was medium sand between 0.4 mm and 0.5 mm.

Figure 13 Bedload transport rates sampled during the period of remedial work.

The highest bedload rates were sampled at the downstream end of the Lower Patch (Figure 13), rather than immediately downstream of the excavator as may have been expected. The unexpectedly low rates sampled downstream of the excavator may have occurred because insufficient time had elapsed for the bedload to be transported to the sample location. The three samples taken downstream of the excavator on April 7th, 2016 were 20 m, 29 m and 34 m downstream from the instream work. These samples were collected for a duration of 10 minutes, meaning the bedload would have had to travel at a rate of 2 m to 3.5 m per minute to reach the sampler. However, in two of these cases, the excavator had been working upstream of the sample site for some time prior to sample collection. In the first case, the excavator was operating about 40 m upstream of the sampling location 28 minutes prior to sample collection. In the second case, the machine was working 25 m upstream of the sample site, roughly 15 minutes before sampling began. Both of these cases would still require the bedload to be transported at a velocity of about 1 m per minute just to reach the sampler before the sampling time had elapsed. For comparison, the highest transport rate was sampled at the downstream extent of the Lower Patch about 1 hour and 50 minutes after the instream work began 100 m upstream, translating to a bedload velocity of roughly 0.8 m per minute. The second and third highest sampled transport rates were also sampled at this location at 13:42 and 13:57 on April 7th, 2016 just after the instream work was completed around 13:00, but the excavator had been working about 55 m upstream of the sample location between 12:40 and 12:50 that afternoon. Assuming the sampled bedload was coming from the remedial work, the sediment would have again been travelling at a downstream velocity of 0.8 m to 1 m per minute. All in all, it is likely that bedload velocity contributes to the explanation of why sampled rates were low downstream of the excavator and why they may have been more representative of actual transport rates at the downstream extent of the Lower Patch. Despite the uncertainty created by bedload transport rates and sample timing, the monitoring evidence does support the finding that remediation was effective.

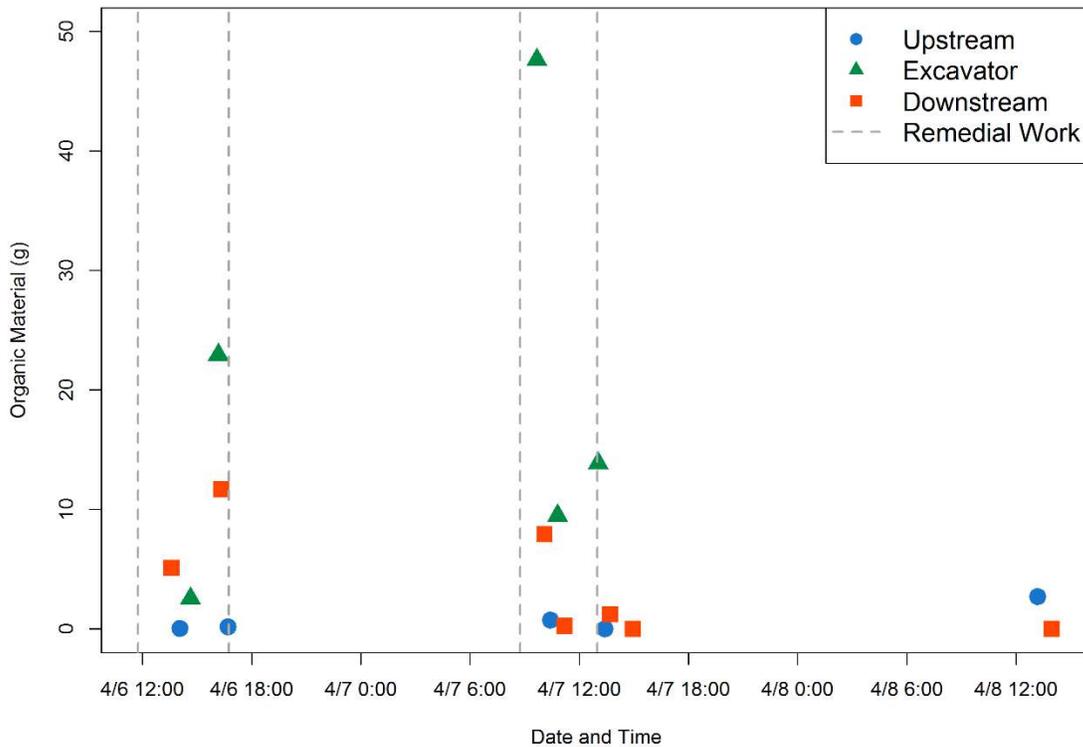
Interestingly, the bedload sediment samples taken directly downstream of the excavator contained a large amount of organic material (Figure 14). The mean amount of organic material contained in these samples was 19.3 g, while samples taken at the upstream and downstream ends of the Lower Patch had an average of 0.7 g and 3.7 g, respectively. The maximum amount of organic material within a sample was 47.6 g, compared to 120.9 g of sediment, in a sample collected downstream of the excavator. All organic material was between 2 mm and 22 mm in size and typically consisted of woody debris.

Figure 14 Organic material collected and excluded from the bedload samples.

As previously mentioned, significantly more organic material was collected by the bedload sampler when sampling downstream of the excavator as compared to the upstream (Figure 14). This suggests that a large amount of organic material, primarily consisting of woody debris, had become lodged within the cobble/gravel substrate of the Lower Patch. This may have been the result of high flow conditions experienced in 2015, when overbank flow was contributing a lot of debris to the channel and the Lower Patch area had very low velocity due to backwatering (NHC, 2016). Regardless of whether the organic matter was primarily a consequence of the flood or whether it has slowly accumulated over time, it is representative of the low near-bed velocity present at the Lower Patch and indicates that bed shear stress remains insufficient to mobilize any of the cobble/gravel to release infilled fines.

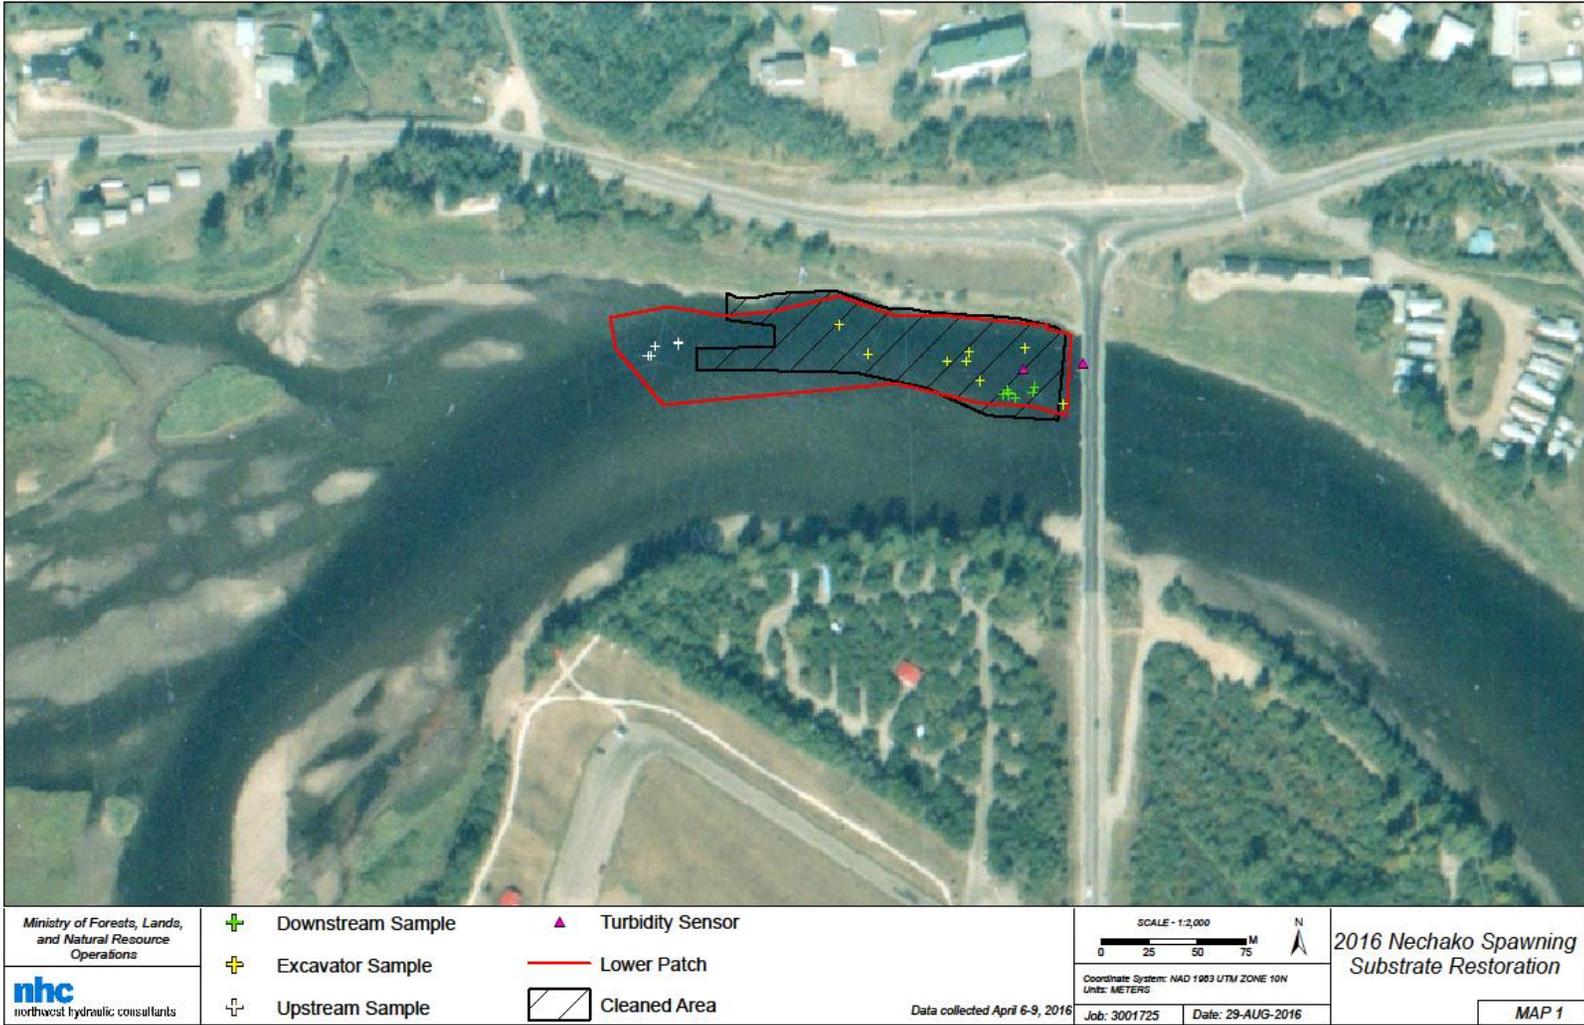
Map 1 Sampling locations and area of Lower Patch restored in 2016

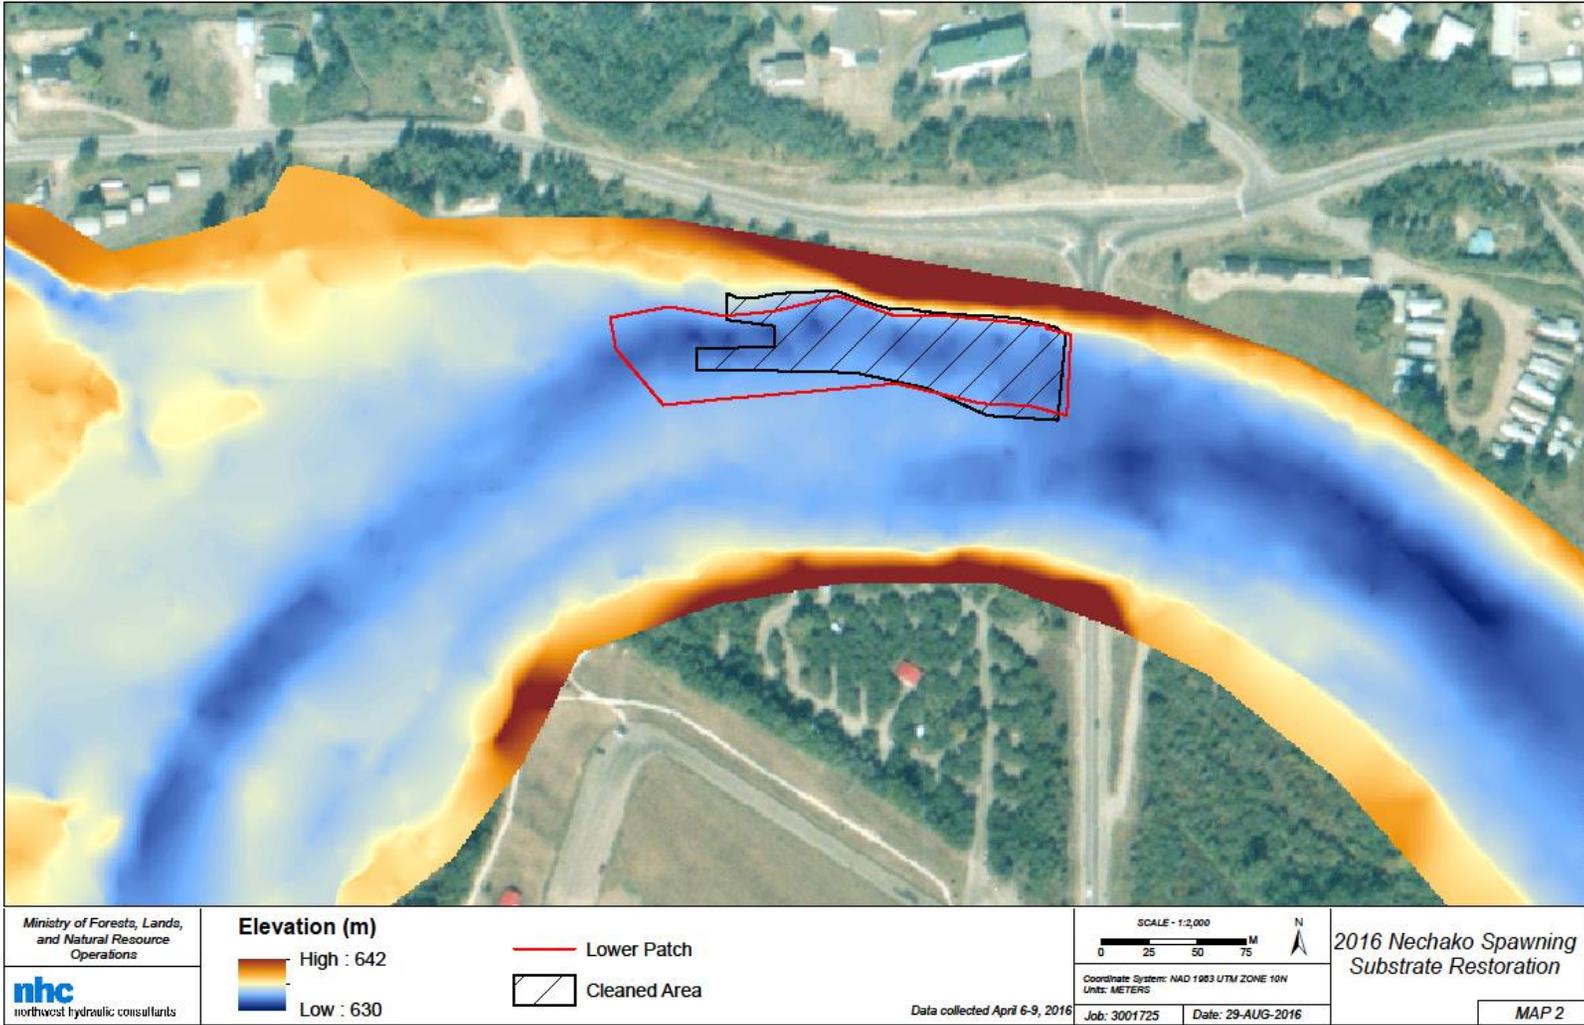
The remedial work was conducted during a discharge of approximately 75 m³/s, which corresponds to an ideally low water level (Table 1). As seen in Map 2 and Map 3, an area of approximately 7,260 m² was accessed by the excavator; this area translates to about 75% of the total Lower Patch area (9,885 m²). The only area that was too deep to access was an approximately 15 m wide section located at the upstream extent of the Lower Patch. The dimensions of the area accessed by the machine are roughly 175 m long by 40 m wide, however, this overestimates the area specifically treated by the bucket due to inevitable gaps left between bucket placements. It remains reasonable to assume that the majority of the area accessed by the excavator was sufficiently mechanically disturbed, either by the tracks or the bucket, to release infilled fines because the spacing between transects was approximately 15 m and it had a reach of approximately 8 m upstream and downstream of each transect. The instream work was conducted over about 10 hours of operation time, until the excavator had reached the downstream extent of the lower Patch.

Map 2 Spatial coverage of the remedial work in 2016 with bed elevation

The spatial extent of the restored area was determined using a combination of GPS track data and a bed topography survey conducted on April 9th, 2016. Although a GPS track from the excavator was intended to be logged during both days of operation, issues with the GPS unit on the first day prevented track data from being collected on April 6th, 2016. For this reason, the boat survey was necessary to fill in the missing track data for the upstream portion of the spawning pad. Fortunately, the restored area was easily delineated during the boat survey by using a depth sounder that clearly depicted the hummocky bed topography left by the excavator during the sifting process. Although the abruptness of the mounds and divots left by the excavator is expected to smoothen over time, it is likely that a generally hummocky bed topography will persist at this location since the cobble/gravel substrate is rarely, if ever, mobilized by the flow.

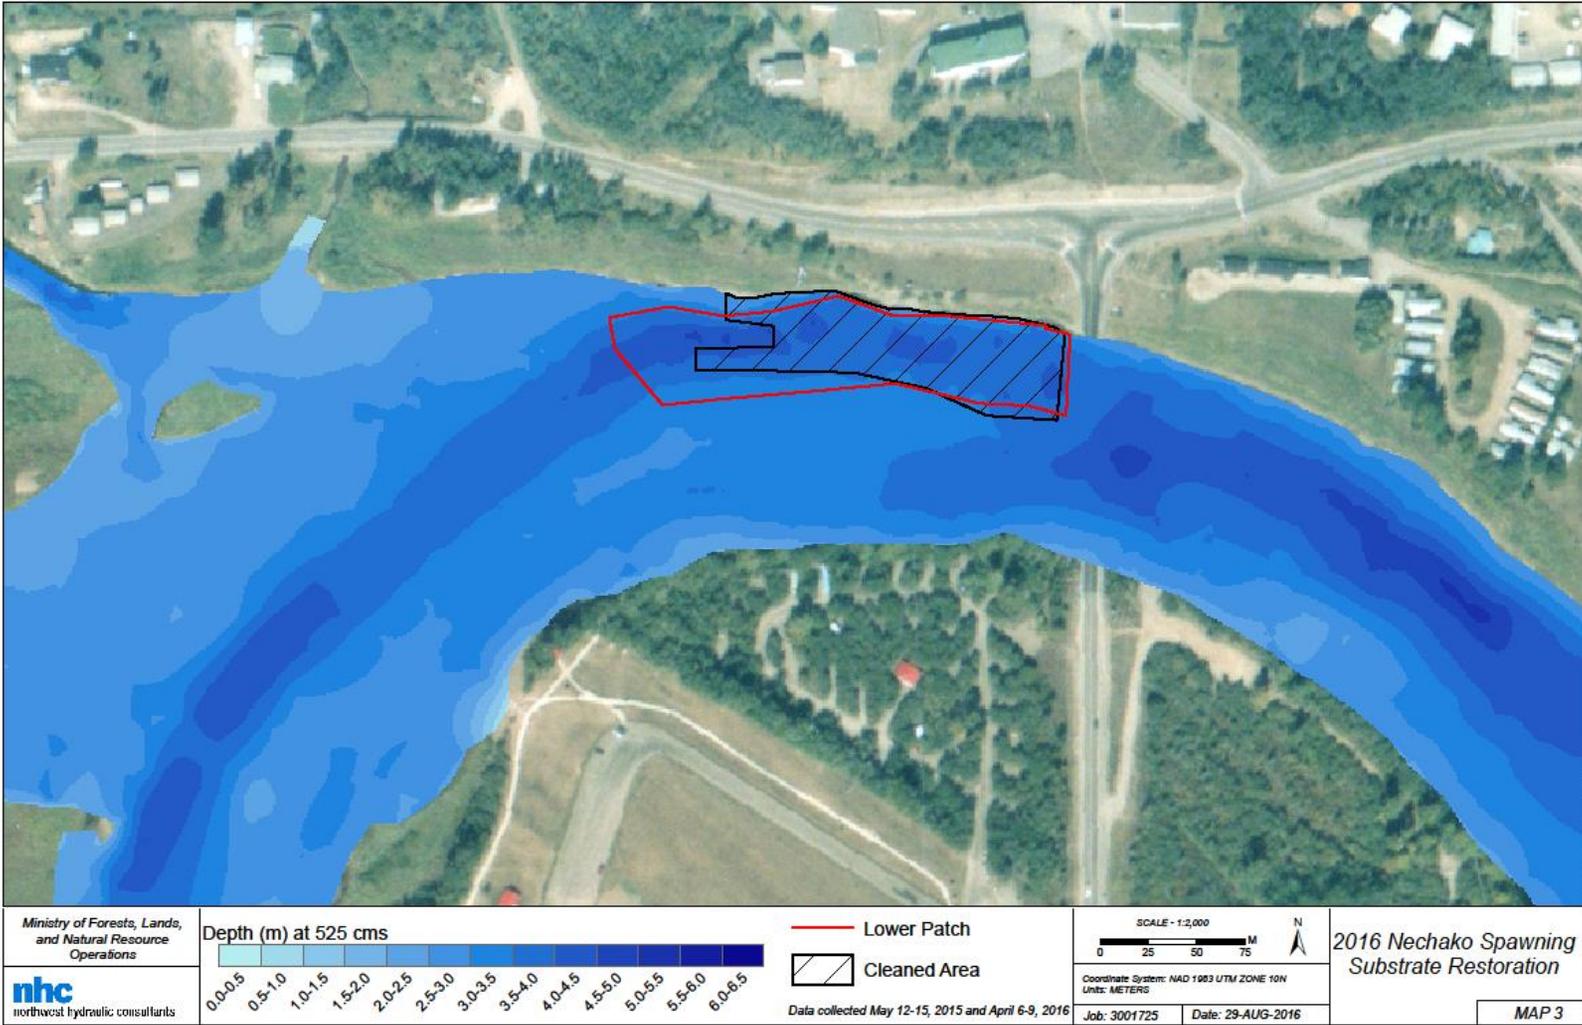
Map 3 Spatial coverage of the remedial work in 2016 with water depth measured during a discharge of 525 m³/s.
